The Olympic Club

**Tree Report
Maintenance Building Project**

Prepared for:
The Olympic Club
599 Skyline Blvd.
San Francisco CA 94132

August 16, 2017

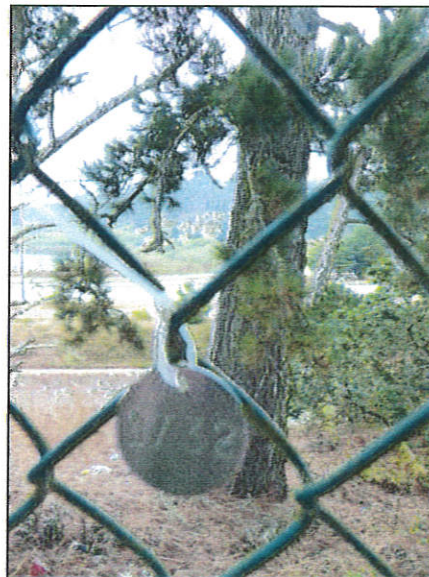
Photo 1. Tags for trees #1723 – 1733 were placed on the adjacent fence as trees could not be accessed directly.

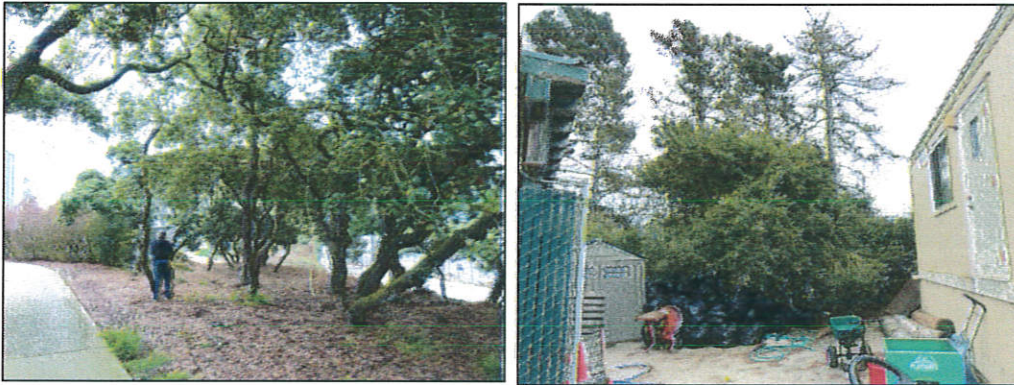
Coast live oak was the most frequently encountered species with 37 trees. Oaks were concentrated along the north and east edges of the project area, located at the top of a slope (Photo 2). Trees were generally short in stature but mature in development. Trunk diameters ranged from 6" to 21". Approximately 50% of oaks had more than one stem originating at or near ground level. Most oaks were in either poor (19 trees) or fair (15) condition. Trees #1718, 1730 and 1739 were in good condition. Differences in tree condition were largely associated overall form and structure, leaning stems, and suppressed development.

Photo 2. Coast live oaks. **Left:** SE. corner of site, near cart path to Ocean #8, in the area where the utilities will be placed underground. **Right:** approximately half of the crown of tree #1725 extended into the project area.

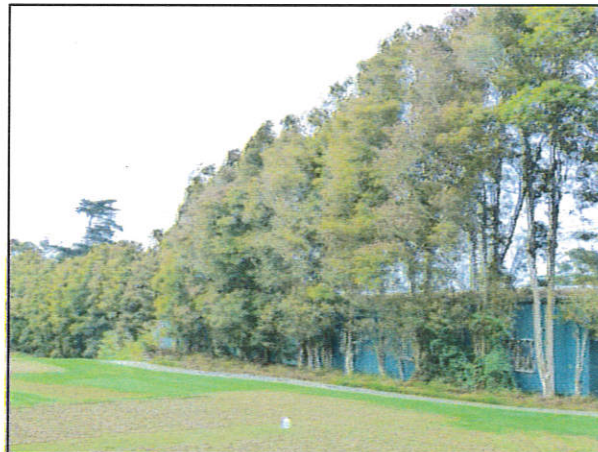
Thirty (30) lily trees formed a long row between the south edge of the existing facility and the 8th hole of the Ocean Course (Photo 3). Trees were planted close together. As a result, individual trees had a narrow upright form and canopy concentrated on the south. Trees appeared to have been topped at 4' many years ago. As a result, most had two or more stems above this point. Most (24) trees were in fair condition while six were poor.

Photo 3. Looking north from tee of #14 Ocean course at screen of lily trees.

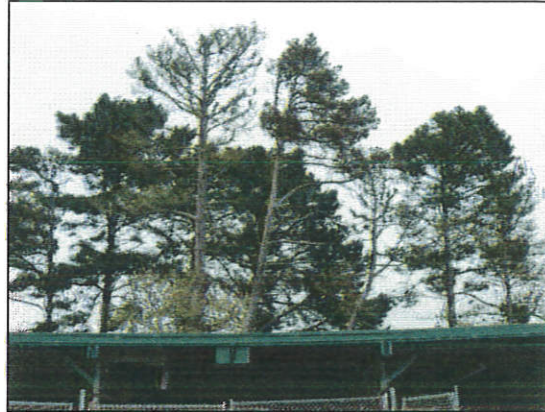
Twelve (12) Monterey pines were present (Photo 4). Trees were generally mature in development. Trunk diameters ranged between 13" and 52". Monterey pine #1703 had a trunk diameter of 52" but this measurement was misleading as one of the two stems of the tree had been removed many years ago. Condition of pines was either poor (2 trees) or fair (5). Trees #1727, 1729, 1731, 1733 and 1744 were dead. Several trees had symptoms of pine pitch canker, a fungal disease. The central leader had been lost in most trees.

Photo 4. Looking north past mower shed.

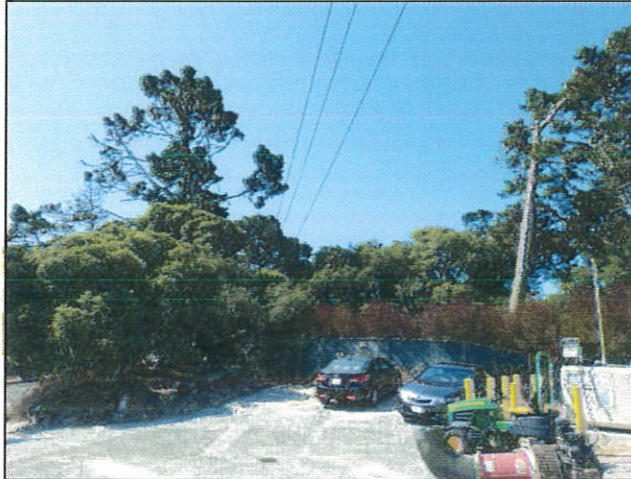
Photo 5. Looking south. Existing overhead electrical lines will be placed underground along the same alignment, necessitating removal of several trees. Monterey pine #1703 is in the center-right of the photograph.

Based on my evaluation of the plans, I recommend preservation of 18 trees (8 Significant) and removal of 64 (12 Significant) (Table 3). Among trees recommended for preservation are 15 coast live oaks and three Monterey pines. Among trees recommended for removal, 48 are located within the project's proposed development area, 11 are located along the alignment of the new underground utilities (Photo 5) and five trees were dead.
