GEOTECHNICAL INVESTIGATION
Landslide Mitigation
Lower Slope at 634 & 636 Palomar Drive
Redwood City, California

June 16, 2017
Job 2572.01.01

Earth Investigations Consultants, Inc.
P.O. Box 795
Pacifica, California 94044
Phone 650-557-0262
earthinvestigations@comcast.net

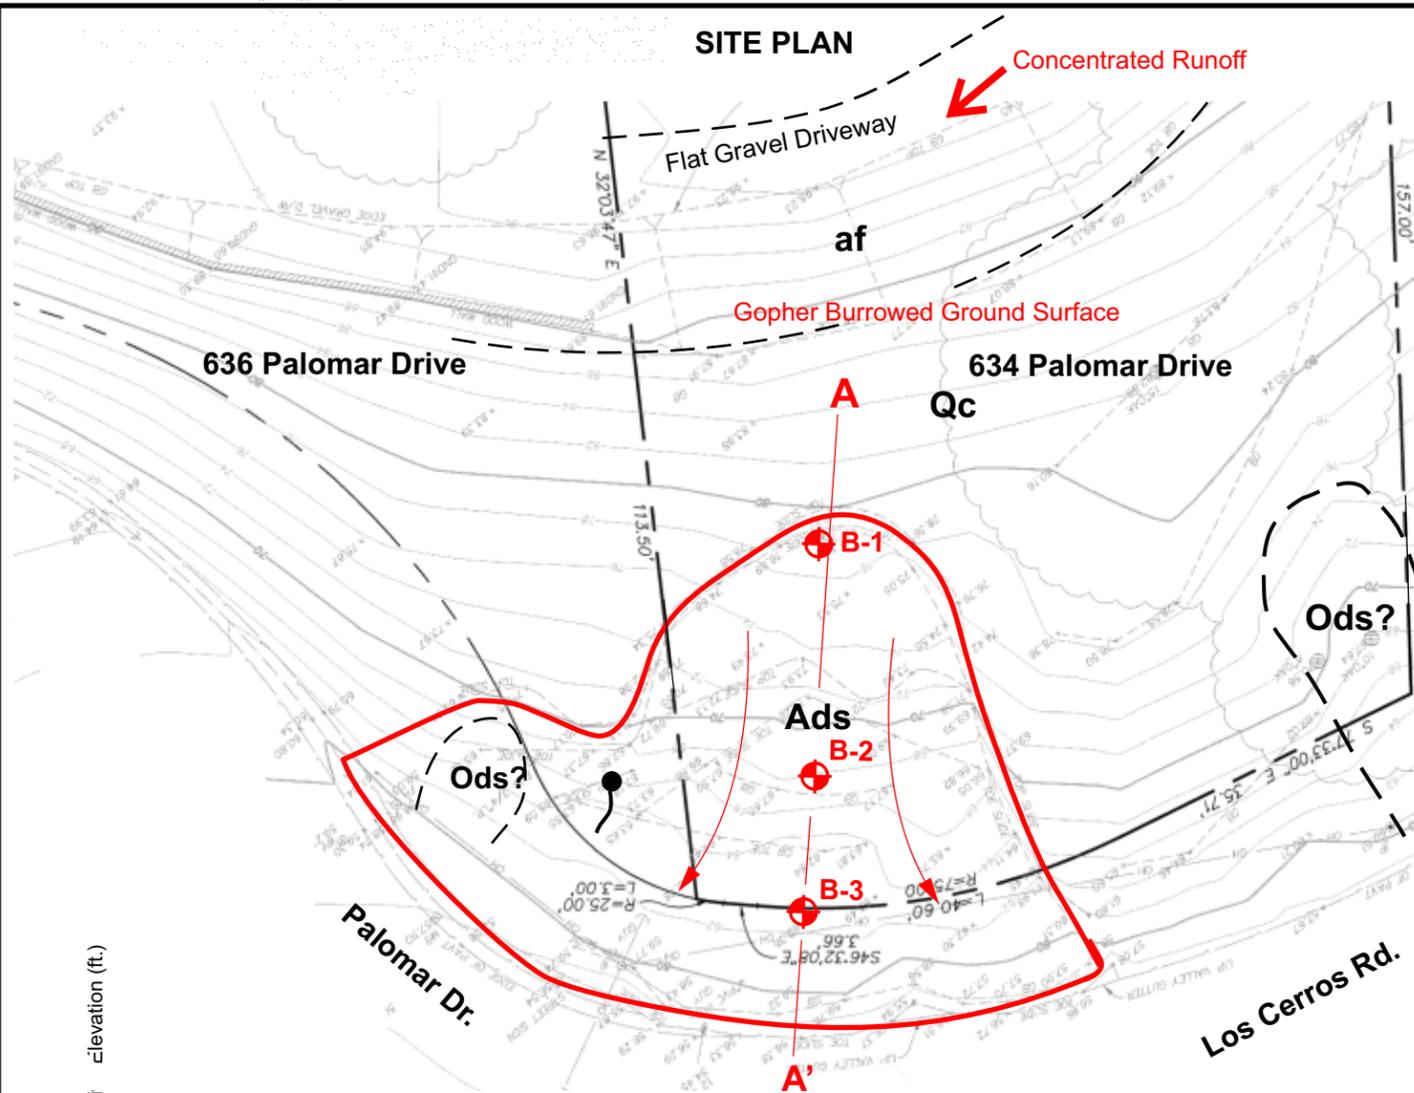
SITE PLAN

The recent landslide depicted on Plate 2 occurred during sustained heavy rainfall this past winter. It comprises approximately 2500 square feet of moderately steep, grassy hillside between Los Cerros Road and Palomar Drive and an unimproved gravel driveway common across the neighbor's property (636 Palomar Drive) and your property (634 Palomar Drive). The surface expression of the slide reflects a retrogressive, primarily rotational failure mode (slump), and secondary translational, surficial debris slide/flow failure mode characterized by angular (serrated) source area headscarps corresponding to orientation of desiccation cracks in the upper-middle part (Plate 2, Photo 1). The headward and perimeter flanks were well-defined by generally vertical escarpments ranging from a few inches up to approximately 3 feet in height. The landslide toe apparently intersected the steep 3- to 4-foot high roadway just above the elevation of the roadway overriding a drainage gutter. Relief of the hummocky and fissured slide surface is approximately 25 feet with an average slope of 20 degrees; roughly the same as the adjoining intact native slope.

Seepage and pooled water was observed on the landslide surface in the lower part of the east flank. Saturated, highly plastic soil, probably representing the basal rupture surface, was observed at the intersection of the right flank and Palomar Drive.

We recommend the landslide be entirely removed and replaced as drained engineered fill (Plate 4). Preliminarily, we judge temporary cut slopes to facilitate benching fill onto competent bedrock will be up to 12 feet high (at the headscarp). The height of cut slopes can be reduced by increasing the frequency of benching. In any event, it will be important for the Contractor to carefully evaluate and maintain grading safety precautions throughout the construction process.

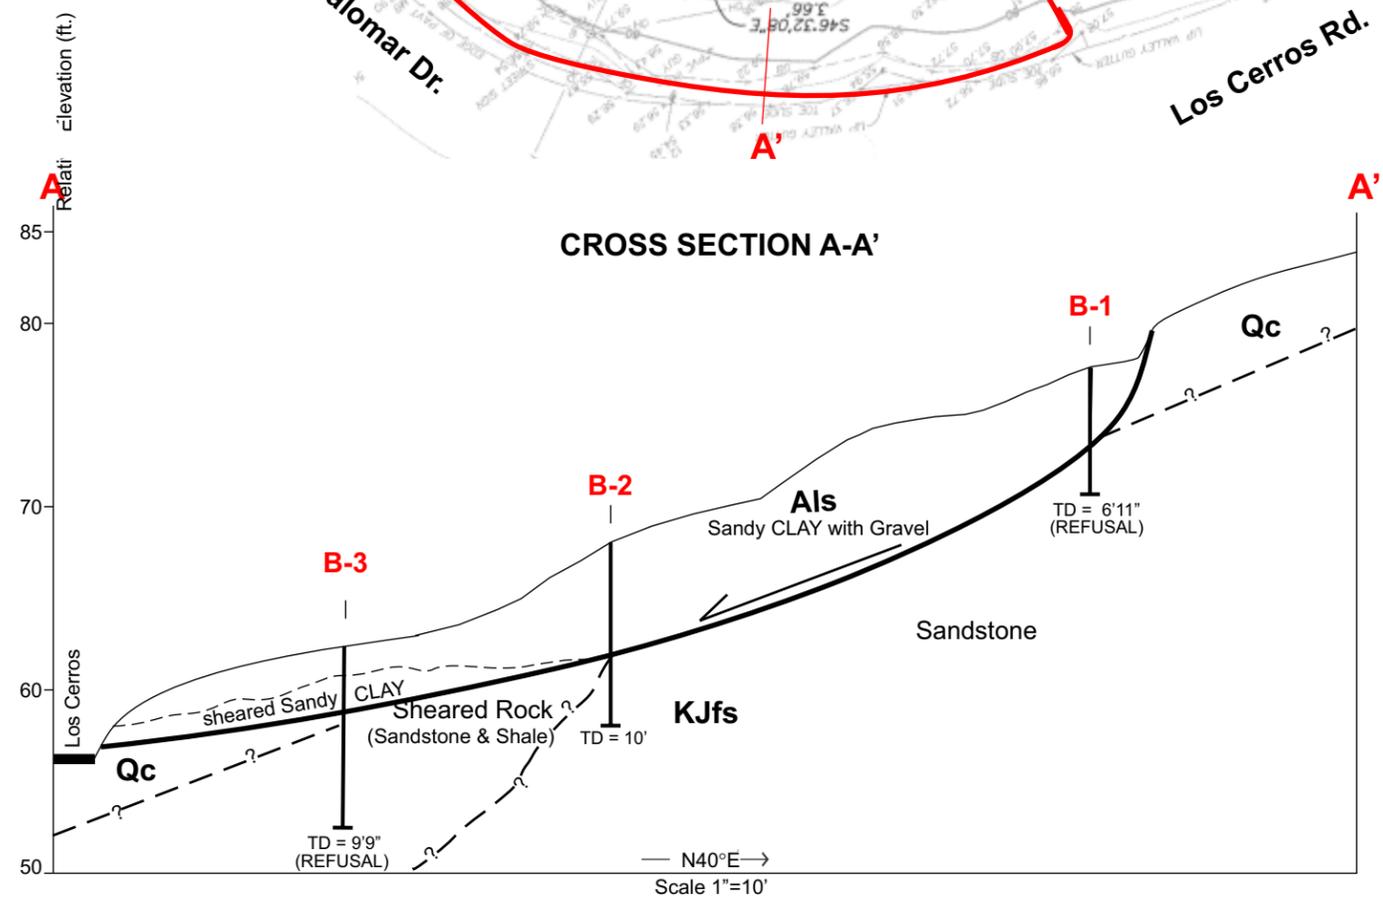
CROSS SECTION A-A'

The borings indicate the central part of the landslide involved up to approximately 6½ feet deep of colluvium and bedrock, including approximately 3 to 4 feet of high plasticity (PI=23) sandy clay with a variable content of gravel-size angular rock fragments, and the upper 2 to 3 feet of Franciscan bedrock, including weathered sandstone and sheared rock (Plate 2, Cross Section A-A' and Plates A1 and A2). Slight seepage was encountered in the upper part of sheared SANDSTONE. Standing water was measured at an approximate depth of 7½ feet upon completion of drilling.

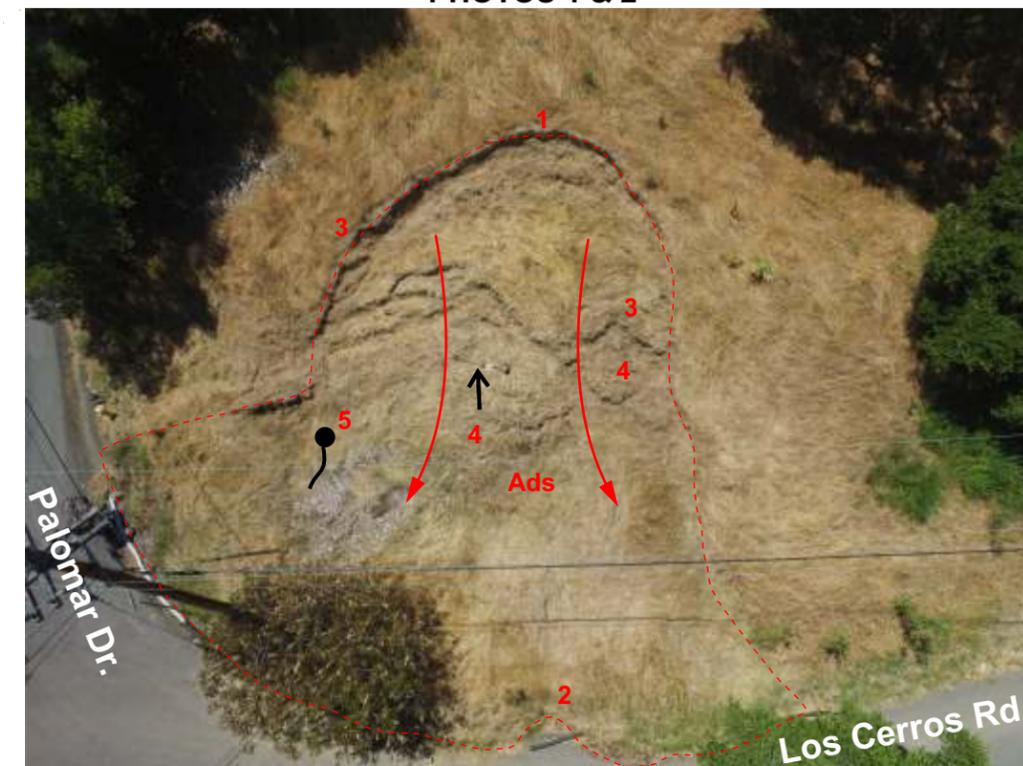
Photo 1: Aerial view of Active Debris Slide. Arrow points to 5 1/2' long weed-wacker for scale.

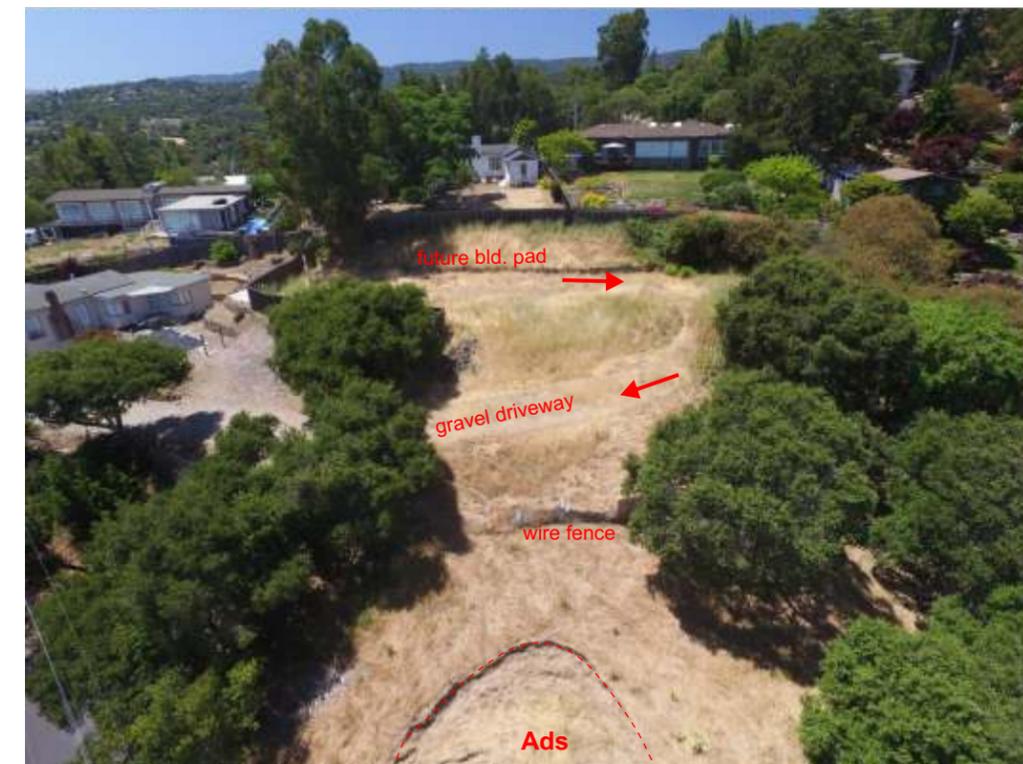
An unimproved dirt road, coinciding with the general alignment of the poorly-drained unimproved gravel road depicted on Plate 2, was detected on 1948 Google Earth imagery. The imagery also revealed substantial reduction of vegetation (clearing?) on the lower part of the slope sometime between 1991 and 2002. A debris flow scar was detected on March 2003 imagery, and previous site topographic mapping, including the recent mapping used for the base of Plate 2, reveal concave upward deflections indicative of past, localized erosion on the lower part of the slope within, and adjacent to the mapped limits of the recent landslide.

Photo 1. Southwesterly oblique view of property uphill of affected slope. Homes at top on Loma Rd.

We believe a concrete V-ditch is not required because of the high probability it will not be maintained over time, and gopher burrowing quickly deems them ineffective. In our opinion, it will be necessary to rely on improvement and maintenance of controlled runoff on the unimproved gravel road upslope, and of canopy and ground cover to mitigate solar exposure and extreme soil temperature variations that results in deep desiccation cracking in this area.

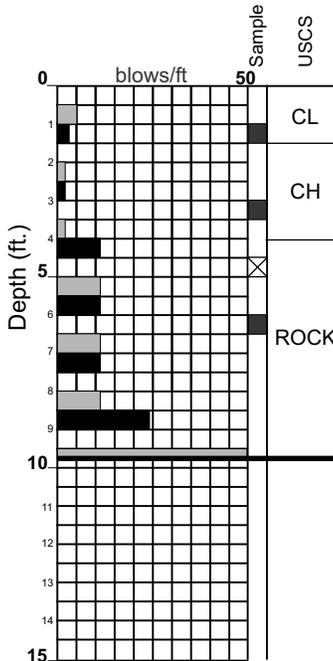
BORING 3

USCS	Description
CL	Yellow brown Sandy CLAY with Gravel, moist, firm (ACTIVE DEBRIS SLIDE, Ads)
CH	Dark yellow brown Sandy CLAY, damp, firm color grades to yellow brown @ 2'; sheared; very plastic CLAY (basal rupture surface) @ 3½'
ROCK	Dark yellow brown SHEARED ROCK, very weathered, closely fractured, soft (BEDROCK, KJfs)

Refusal @ 9'9"
