PREPARED FOR: DREAMWORKS CONSTRUCTION  
**TOPOGRAPHIC SURVEY**  
 LANGLEY HILL ROAD  
 SAN MATEO, CALIFORNIA

# UPDATED BIOLOGICAL RESOURCES EVALUATION

70 Langley Hill Road  
San Mateo County, California

March 2017

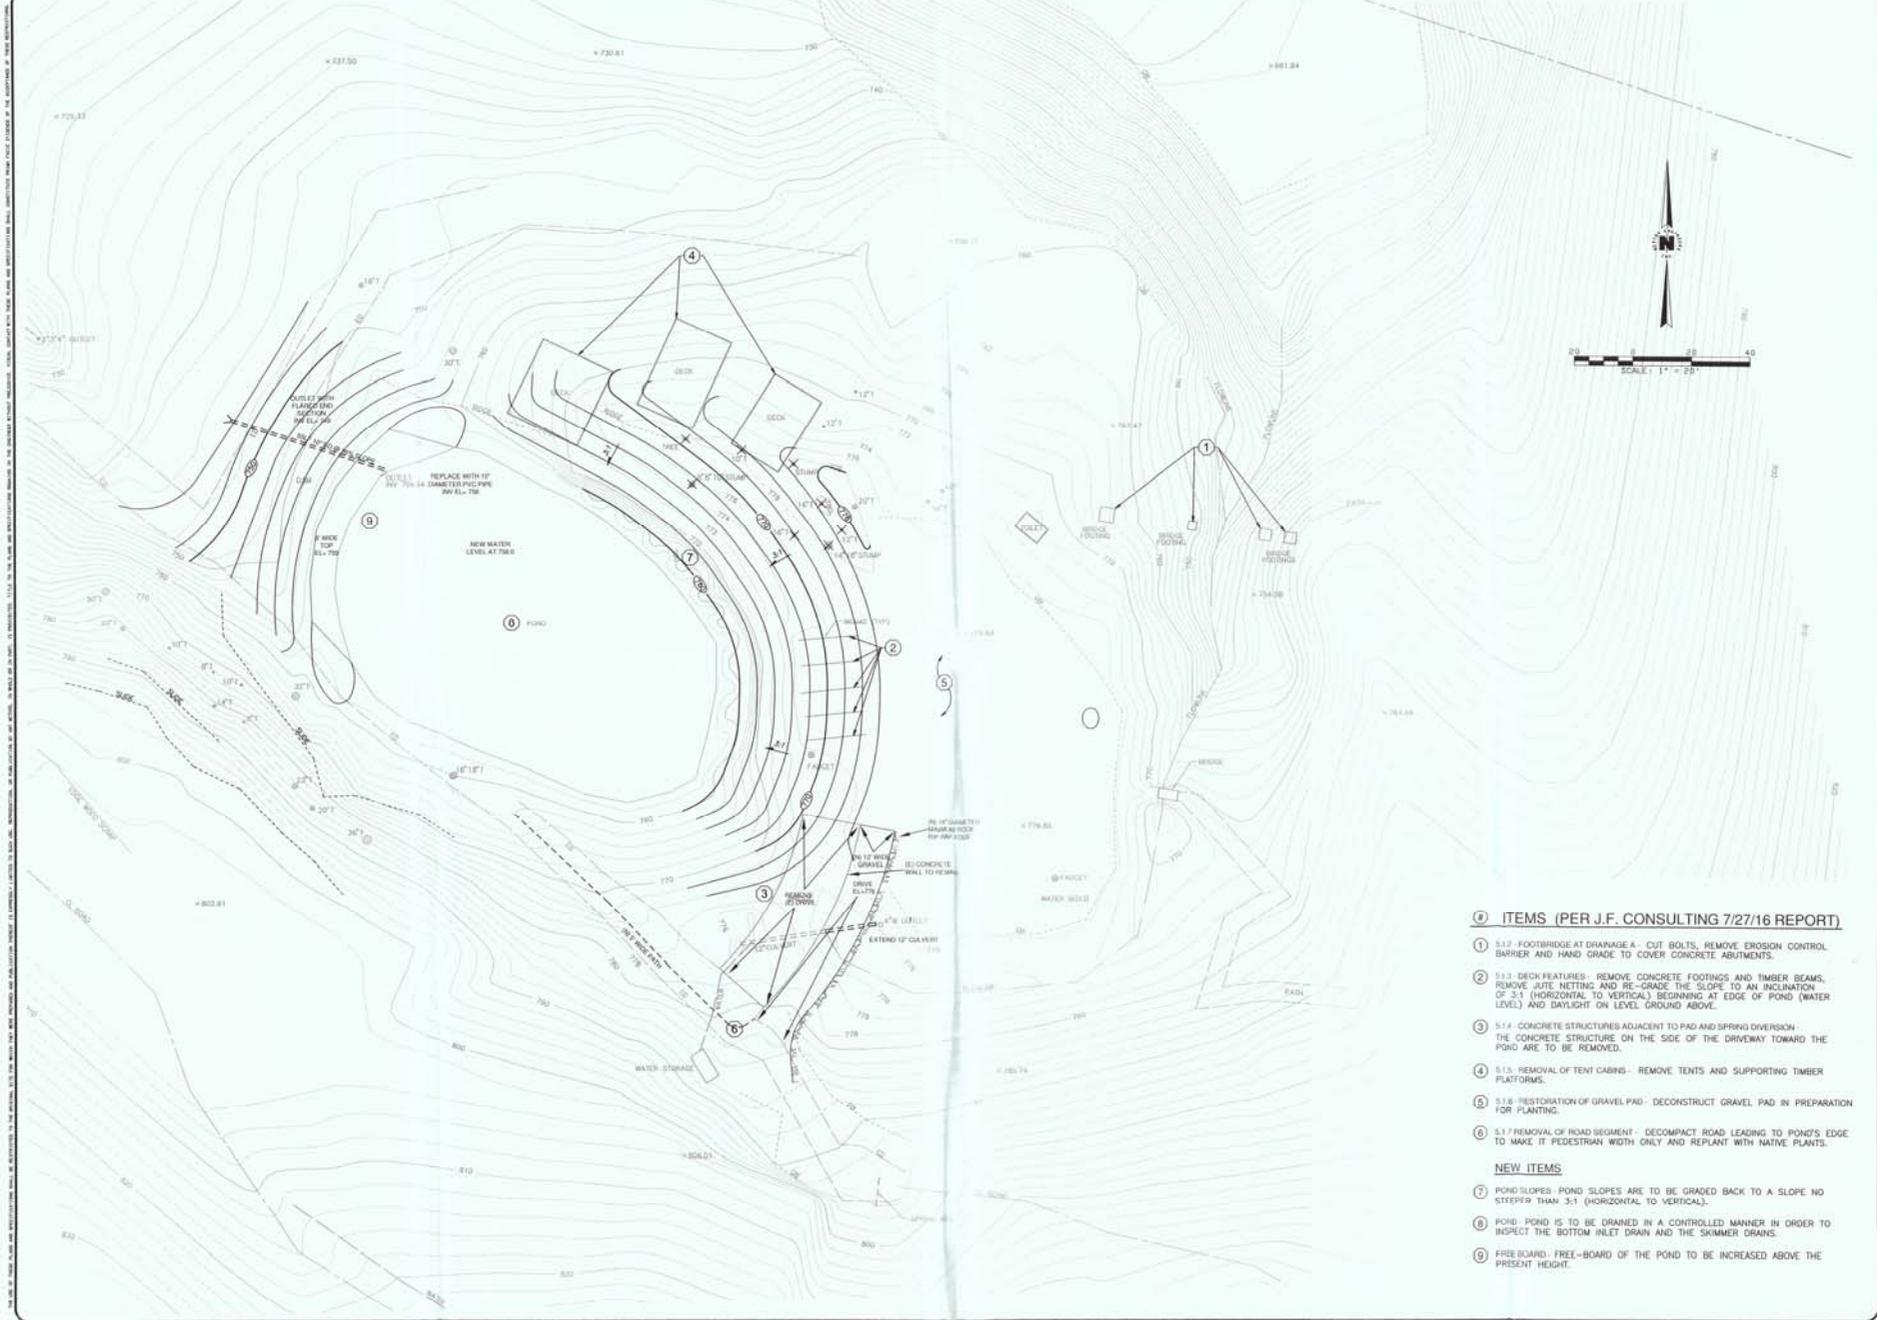
SCALE:	1" = 20'
DATE:	9/29/16
SHEET:	T1.1
NO:	6955.00

**④ ITEMS (PER J.F. CONSULTING 7/27/16 REPORT)**

- ① 51.2 FOOTBRIDGE AT DRAINAGE A - CUT BOLTS, REMOVE EROSION CONTROL BARRIER AND HAND GRADE TO COVER CONCRETE ABUTMENTS.
- ② 51.3 DECK FEATURES - REMOVE CONCRETE FOOTINGS AND TIMBER BEAMS, REMOVE JOIST NETTING AND RE-GRADE THE SLOPE TO AN INCLINATION OF 3:1 (HORIZONTAL TO VERTICAL) BEGINNING AT EDGE OF POND (WATER LEVEL) AND DAYLIGHT ON LEVEL GROUND ABOVE.
- ③ 51.4 CONCRETE STRUCTURES ADJACENT TO PAD AND SPRING DIVERSION - THE CONCRETE STRUCTURE ON THE SIDE OF THE DRIVEWAY TOWARD THE POND ARE TO BE REMOVED.
- ④ 51.5 REMOVAL OF TENT CABINS - REMOVE TENTS AND SUPPORTING TIMBER PLATFORMS.
- ⑤ 51.6 RESTORATION OF GRAVEL PAD - DECONSTRUCT GRAVEL PAD IN PREPARATION FOR PLANTING.
- ⑥ 51.7 REMOVAL OF ROAD SEGMENT - DECOMPACT ROAD LEADING TO POND'S EDGE TO MAKE IT PEDESTRIAN WIDTH ONLY AND REPLANT WITH NATIVE PLANTS.

**NEW ITEMS**

- ⑦ POND SLOPES - POND SLOPES ARE TO BE GRADED BACK TO A SLOPE NO STEEPER THAN 3:1 (HORIZONTAL TO VERTICAL).
- ⑧ POND POND IS TO BE DRAINED IN A CONTROLLED MANNER IN ORDER TO INSPECT THE BOTTOM INLET DRAIN AND THE SKIMMER DRAINS.
- ⑨ FREE BOARD - FREE-BOARD OF THE POND TO BE INCREASED ABOVE THE PRESENT HEIGHT.

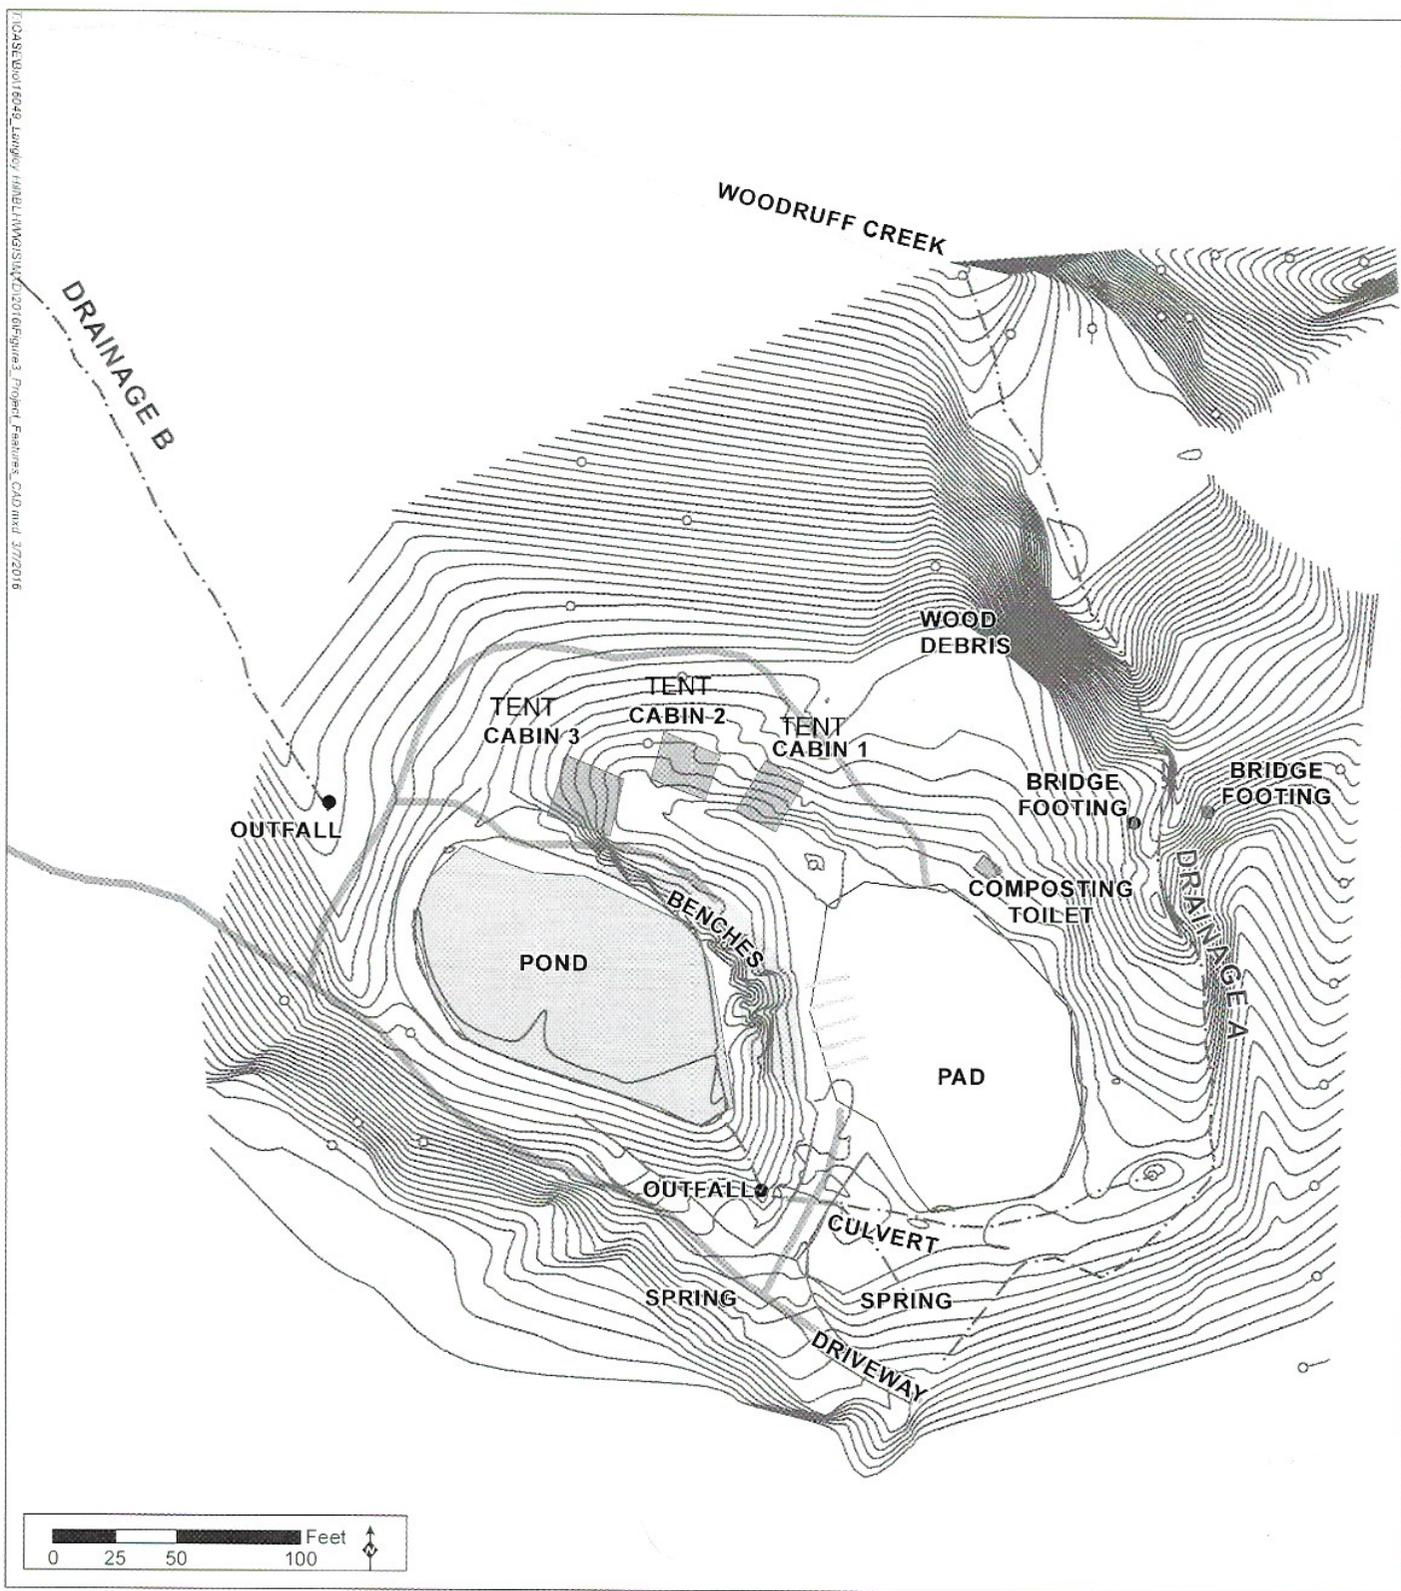
- Roads
- Beams
- Bridge footing
- Composting toilet
- Culvert
- Earthen benches
- Gravel pad
- Pond
- Tent cabin

There is a segment of earthen road that connects the entrance road to another earthen road on the west side of the pond that leads down along Drainage B. This short segment of road is directly adjacent to the pond, is not used as a road, and is redundant with a road behind the tent cabins so it is not required for access (Figure 3).

Drainage A (Figure 3) drains surface water and water from a spring. The composting toilet is located at the top of this tributary's west bank at the eastern end of the dirt pad. The toilet contains all waste within a buried container and does not leach into the soil. As noted above, the property owner had begun to build a bridge over Drainage A. Cement footings are located at the top of bank on either side of the drainage. Some soil disturbance has occurred on the two banks and the County required erosion control measures here (described below).

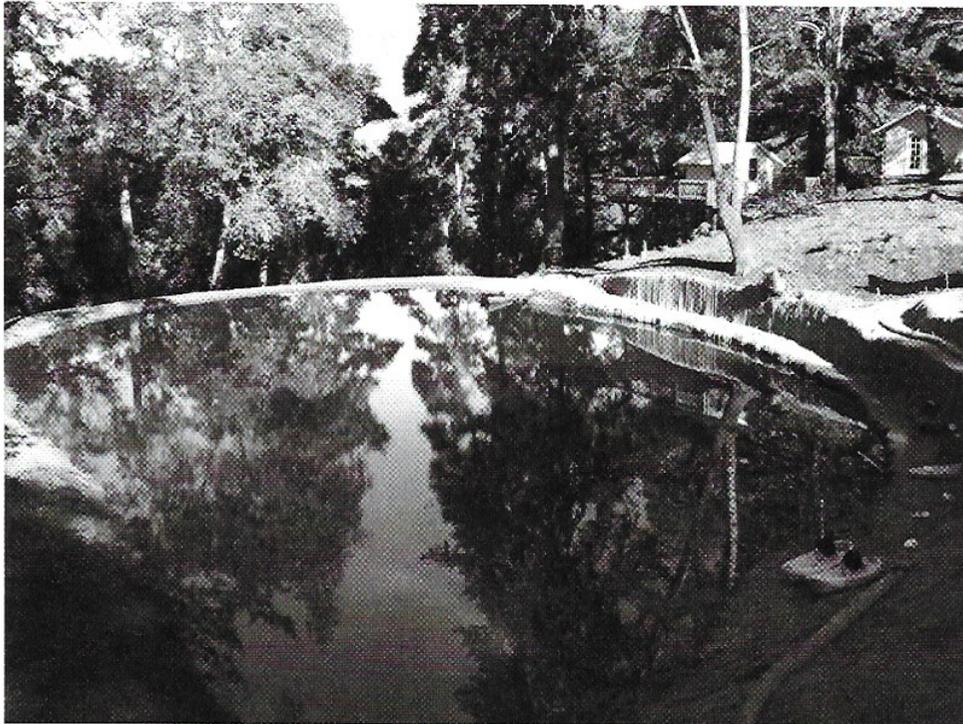
Photo 1. View of the pond standing above the inlet. Two of three tent cabins can be seen in the background. To the right is the terracing that has been blanketed in erosion control netting.

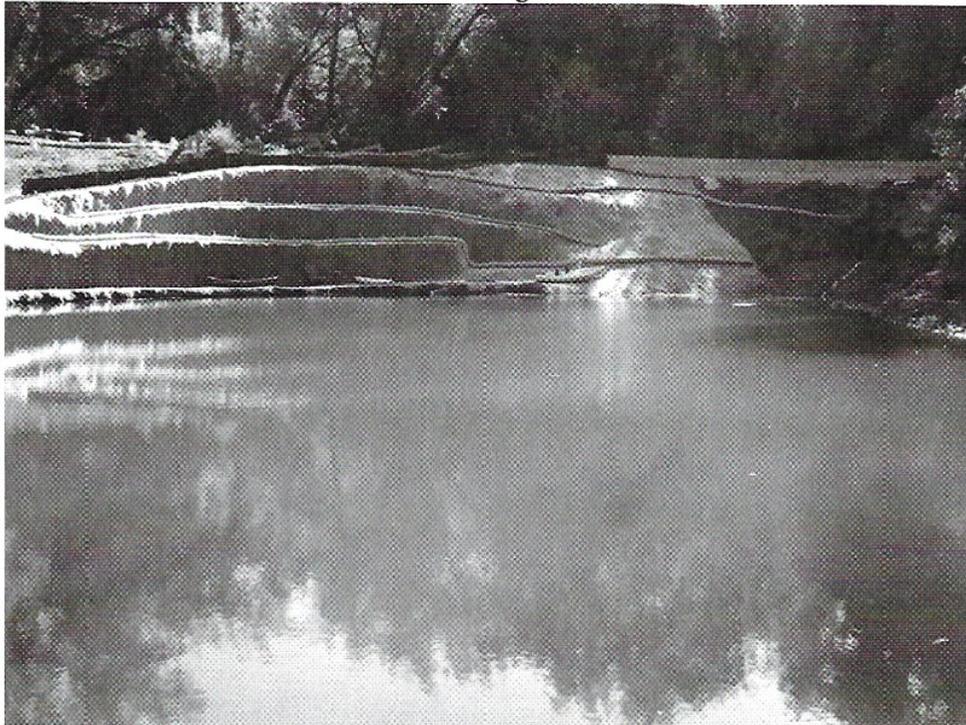
Photo 2. View of the pond and deck terracing from the outlet side. Drainage feeding pond can be seen in the upper right side.

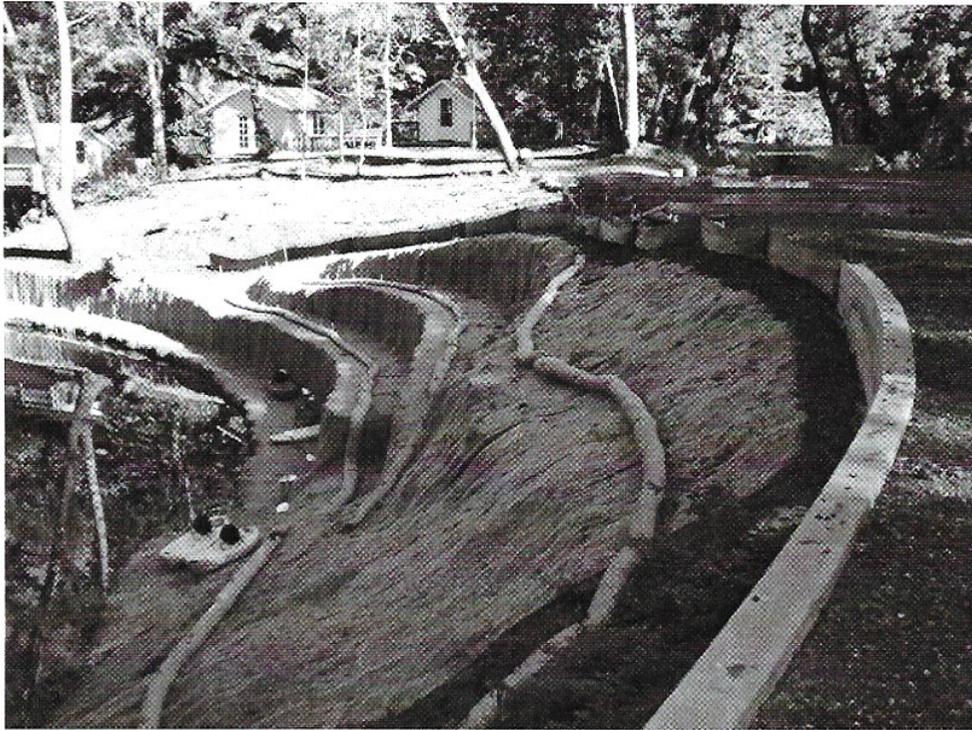
Photo 3. Terracing, partial deck construction, and three tent cabins.

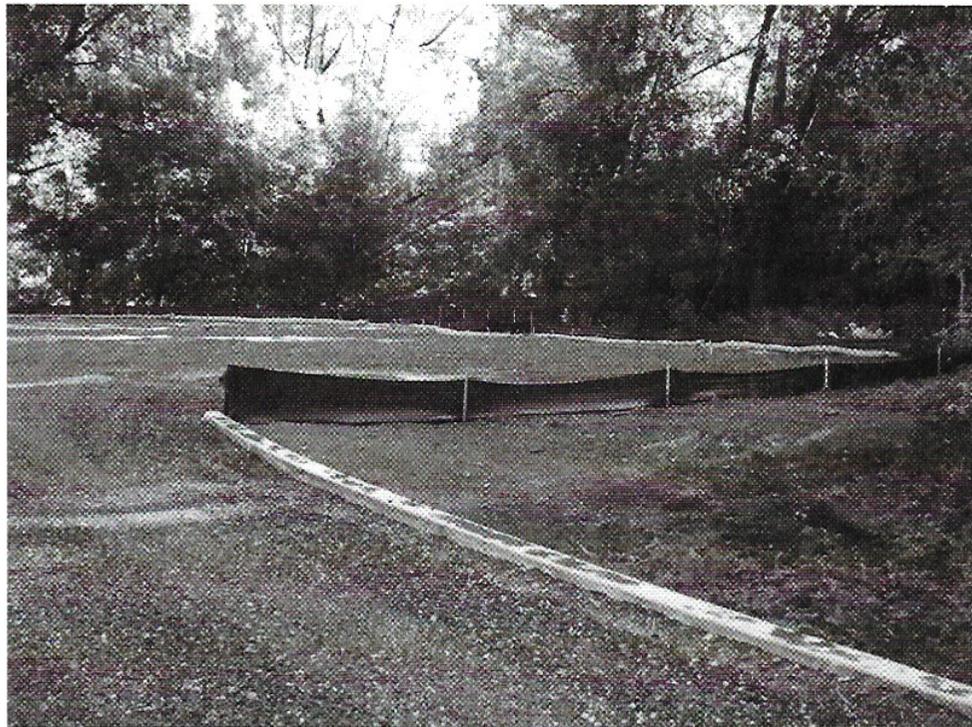
Photo 4. Dirt and gravel pad, presumable made from excavated fill when the pond was created.

- Remove the gravel pad within ten feet of the pond and spring and 25 feet of the top of slope adjacent to Drainage A, decompact, and revegetate these areas;
- Remove the concrete wall adjacent to the pond and restore the area to a 3:1 slope (requires spring diversion and draining the pond);
- Remove the tent cabins and footings;
- Inspect the drainage structures and the base of the existing berm (this requires spring diversion and draining the pond);
- Construct a new berm adjacent to the outward side of the existing berm on the west side of the pond; and
- Decompact the dirt road bordering the south side of the pond and revegetate with native species.

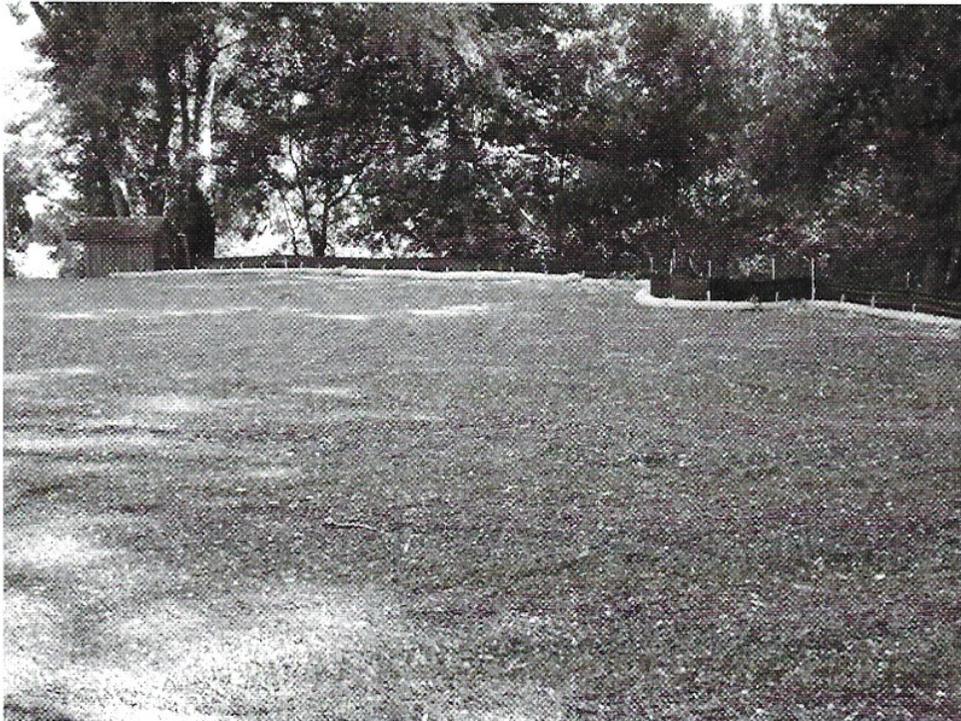
Photo 5. Composting toilet positioned at the edge of the pad.

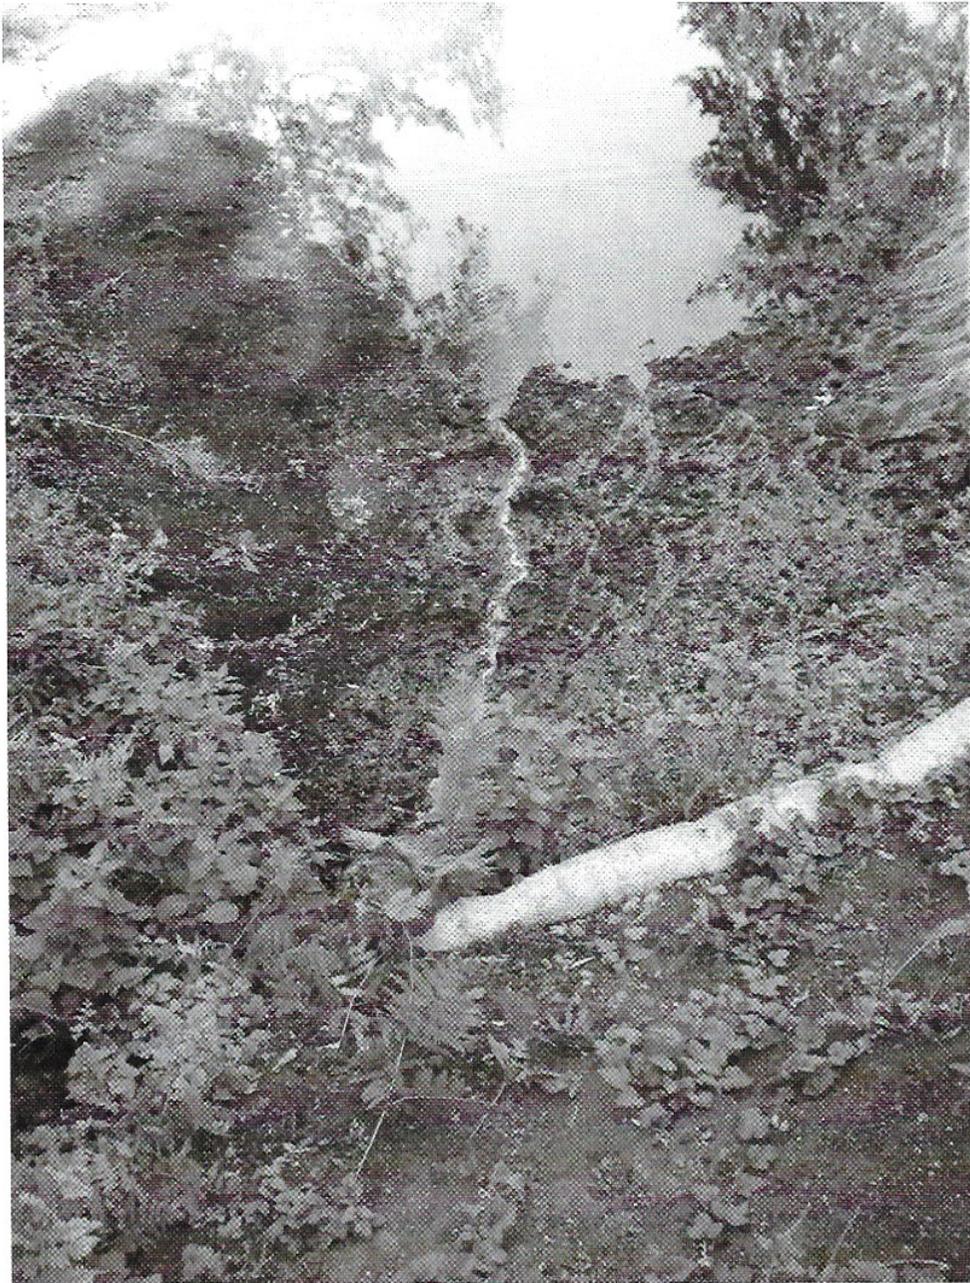
Photo 6. A culvert conveys from a spring to the pond.

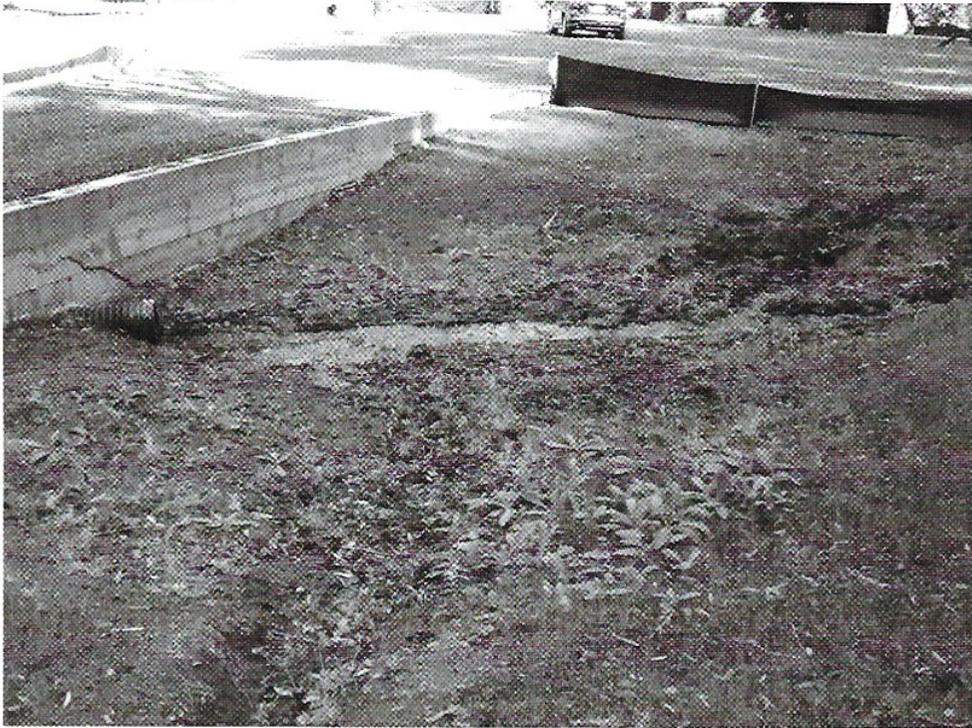
Photo 7. The upstream side of the culvert that discharges to the pond.

**Impacts:** A concrete road structure between the end of the access road and the pad is built across a spring-fed channel, and the water is conveyed through a 12-inch plastic pipe imbedded in the concrete. Water collects upstream of this structure and wetland vegetation has developed. Below the culvert, soil is eroding as water flows down a narrow earthen rill to the pond. Possible options are to leave it in place, remove it and replace it with a small bridge (free span) over the drainage, or replace it with a new culvert that discharges closer to the pond edge in order to correct for the erosion created by the existing elevation of the outfall. The geotechnical report recommends that the concrete structure on the side of the driveway toward the pond be removed, and that the area be graded to create a 3:1 slope from the pond's edge to level ground above. The road would be re-aligned upstream and the existing upslope concrete wall would remain. The impacts for this activity are the same as for the Pond Bank Terraces described in Section 5.3, assuming that this work would include draining the pond.

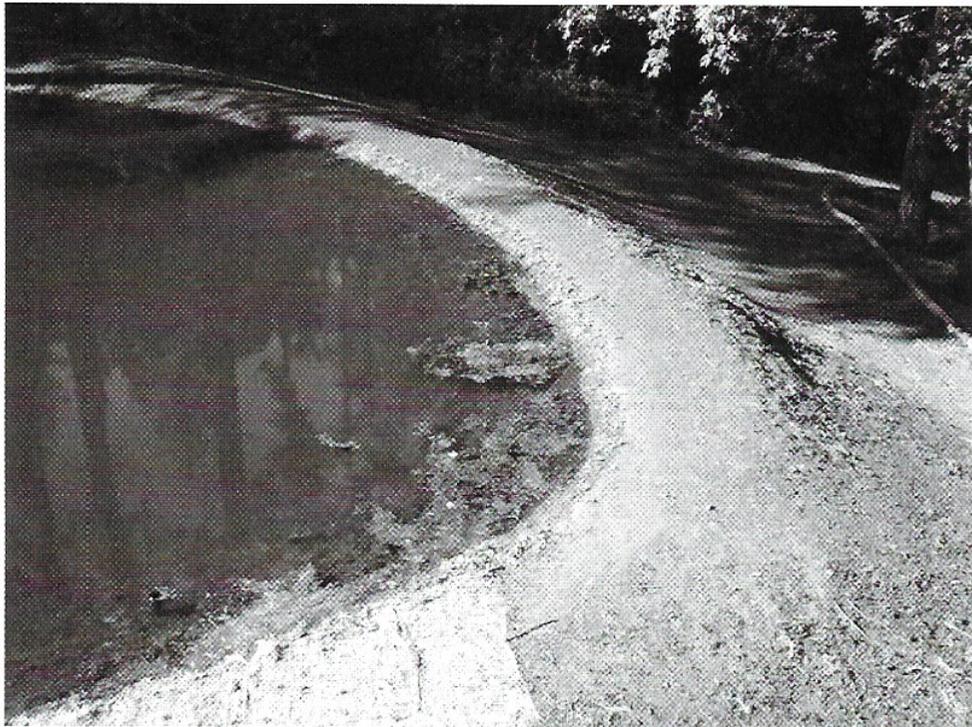
Photo 8. The pond's earthen berm. One of the vertical pipes for outflow can be seen in the bottom left.

**Impacts:** The geotechnical report recommends that the pond be drained in a controlled manner in order to inspect the bottom inlet drain and the skimmer drains, because the drain pipes may be under sized and were hurriedly backfilled, such that there is a potential risk of dam failure and a sudden release of all the water in the pond. Because draining the pond could adversely affect special-status species that could occur there, and could impact water quality downstream and impact special-status species off-site, AMMs regarding the methods used to drain the pond and protect water quality are recommended. These measures are described above for the Pond Terraces Grading project (5.2, above). It is assumed that the pond would be allowed to re-fill once the inspection/repairs are complete.

**Impacts:** The geotechnical report recommends that the free-board of the pond be increased above the present height by constructing a new pond embankment down slope and adjacent to the existing embankment. The soil for this embankment would be native soil generated on site in reducing slope inclinations to 3:1. The top of the embankment should be about 8 feet wide and should be level, according to the report. The outboard slope of the embankment should be no steeper than 3:1 (horizontal to vertical). The embankment would be located in an area of barren ground that does not support vegetation. If burrows are present in this area the project could result in a significant impact to special-status species that use burrows in upland habitat.

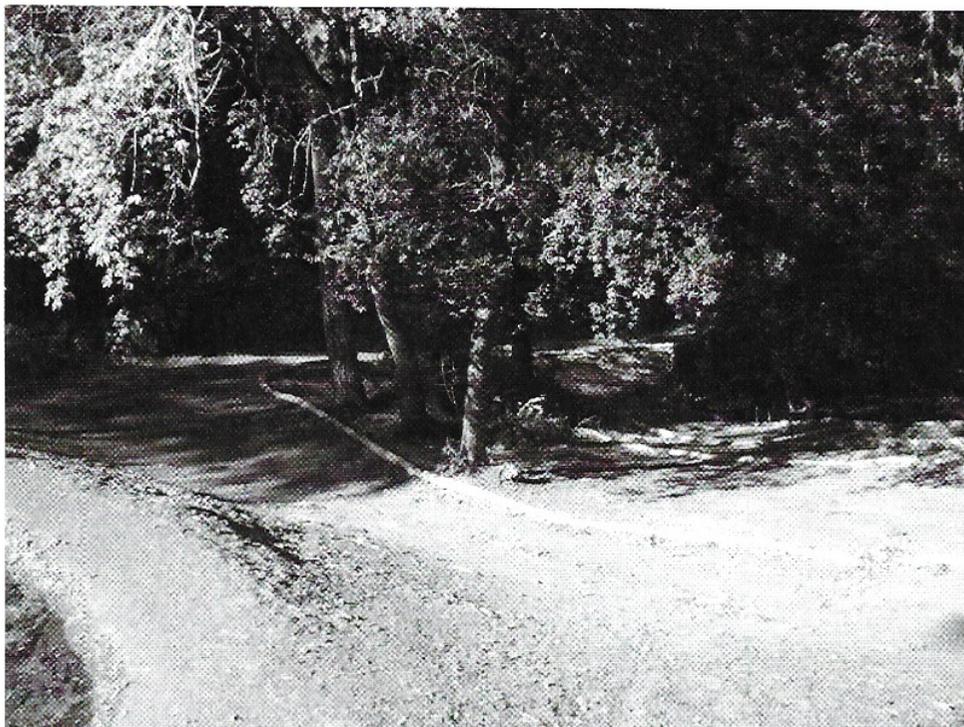
Photo 9. The face of the earthen berm with erosion control straw wattles installed per County requirement.

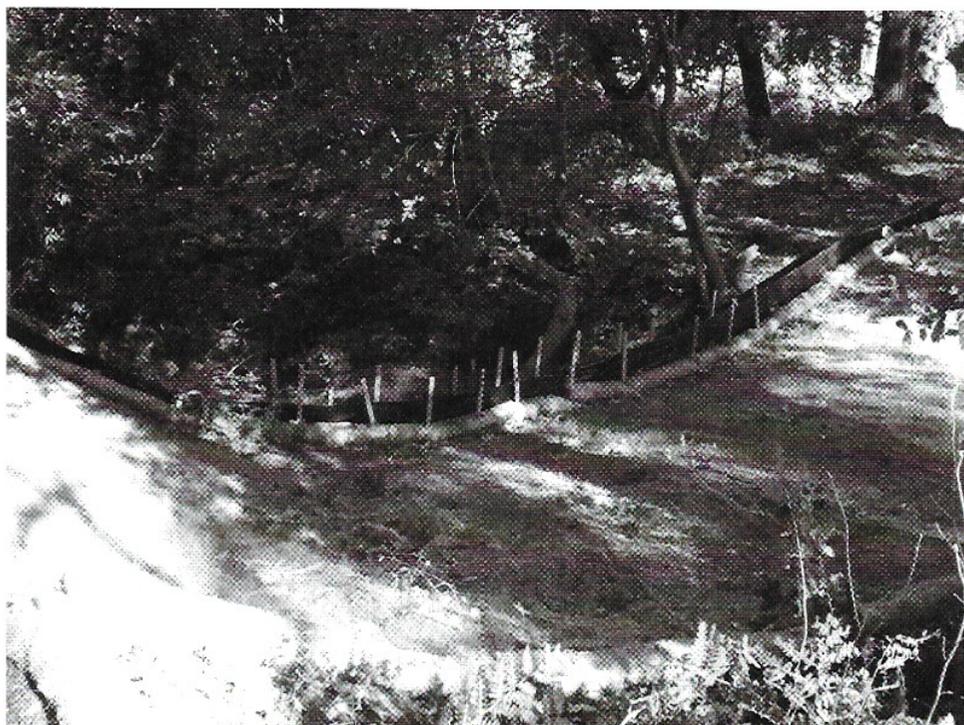
Photo 9. The toe of the berm, erosion control netting and seeding that has sprouted. The culvert discharges into drainage B just below the silt fence.

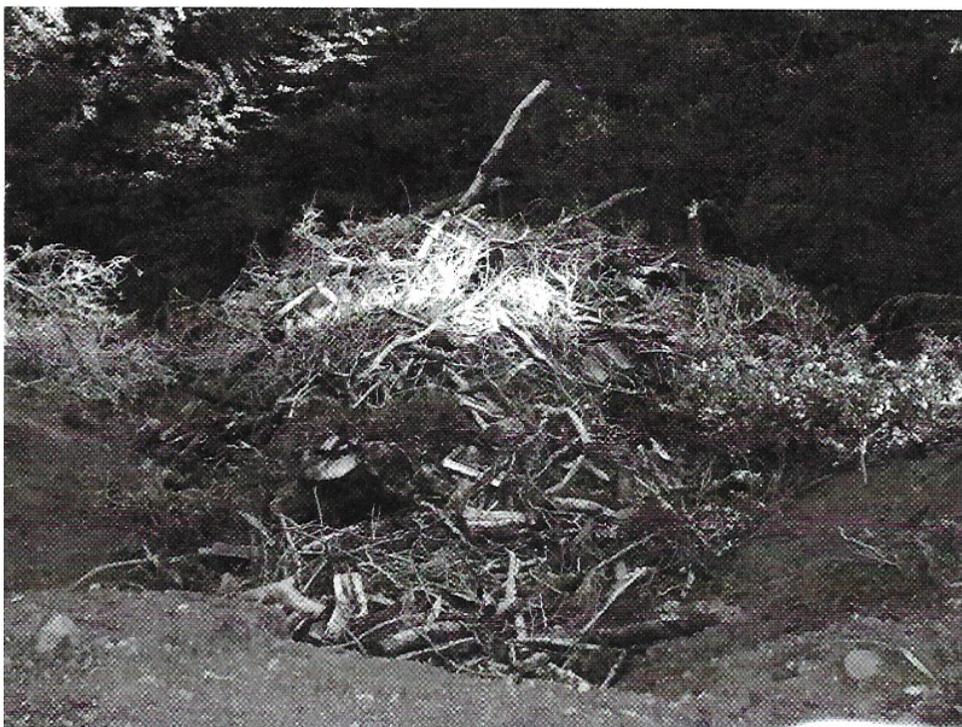
A large amount of woody material primarily from downed trees had been collected and piled behind the tent cabins and at the edge of the property. This pile was at the top of a steep ravine that is also the south bank of Woodruff Creek. The significant weight of the wood caused the embankment to collapse into the ravine, although it appears that little, if any, material fell into the creek. The collapse mimicked a natural slope failure which provides habitat for early colonizing plant species and small wildlife species including insects, reptiles, amphibians and mammals.

Photo 10. Large wood debris pile that collapsed the ravine embankment.

**AMM-1:** It is recommended that the material on the slope failure be left in place and that no action be taken to remove it. Removal would cause more disturbance of the embankment and could result in adverse impacts to the creek caused by debris and soil falling into the creek channel and affecting creek flows. In addition, the debris may now provide habitat for roosting bats, reptiles, and birds. Removal of the debris may negatively impact wildlife.

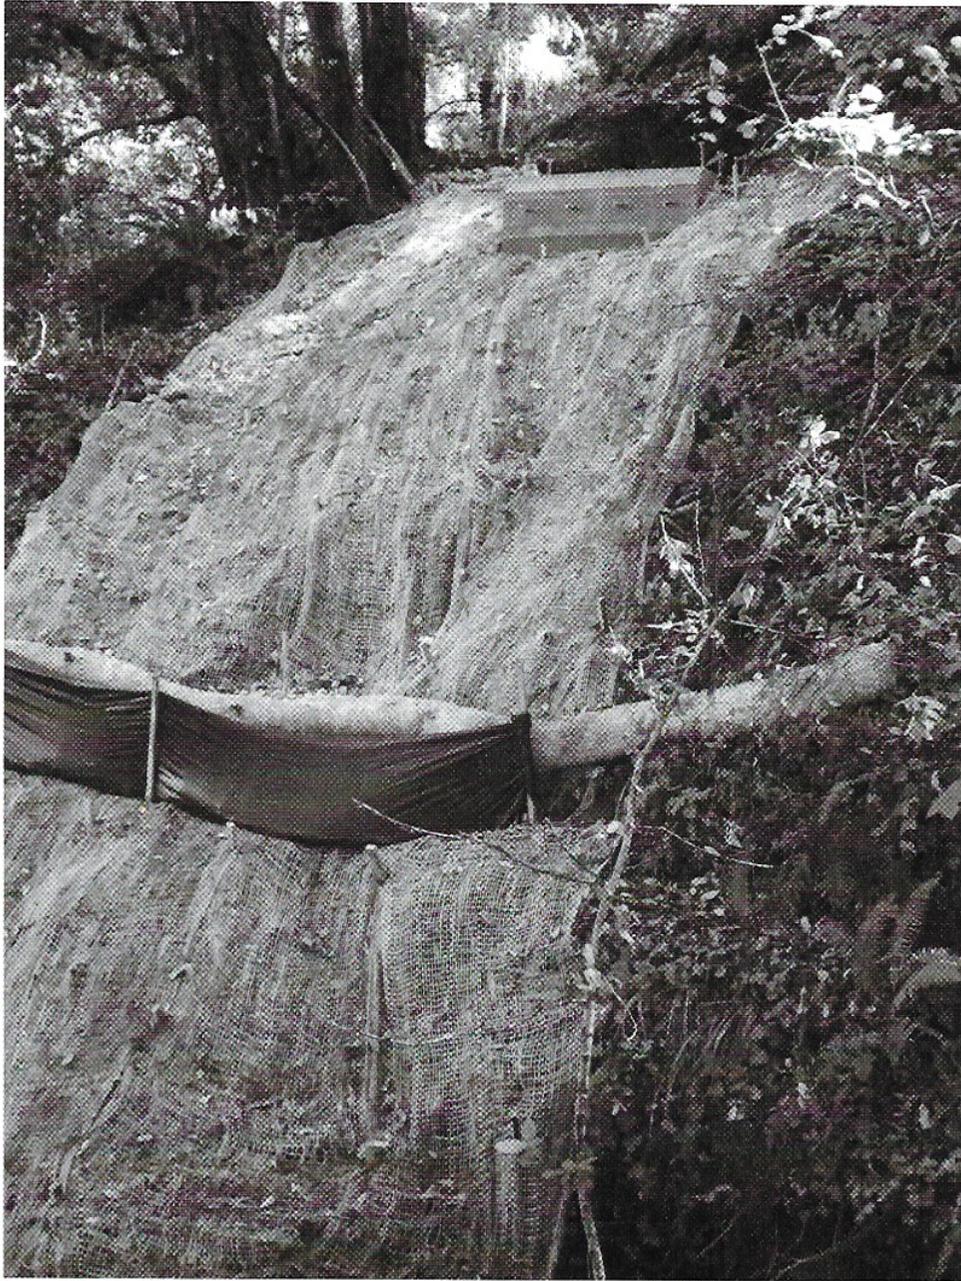
Photo 11. Concrete bridge footing for a planned bridge at drainage A. The County required erosion control measures implemented on the steep drainage banks.

**Impacts:** The project leaves the concrete footings in place, cuts off the bolts that pose a safety hazard, and removes the erosion control fencing downslope of the footings. The footings would be buried by hand to match the existing grade. Leaving the footings in place is not expected to result in an impact to biological resources. The erosion control fencing should be removed after the footings are buried.

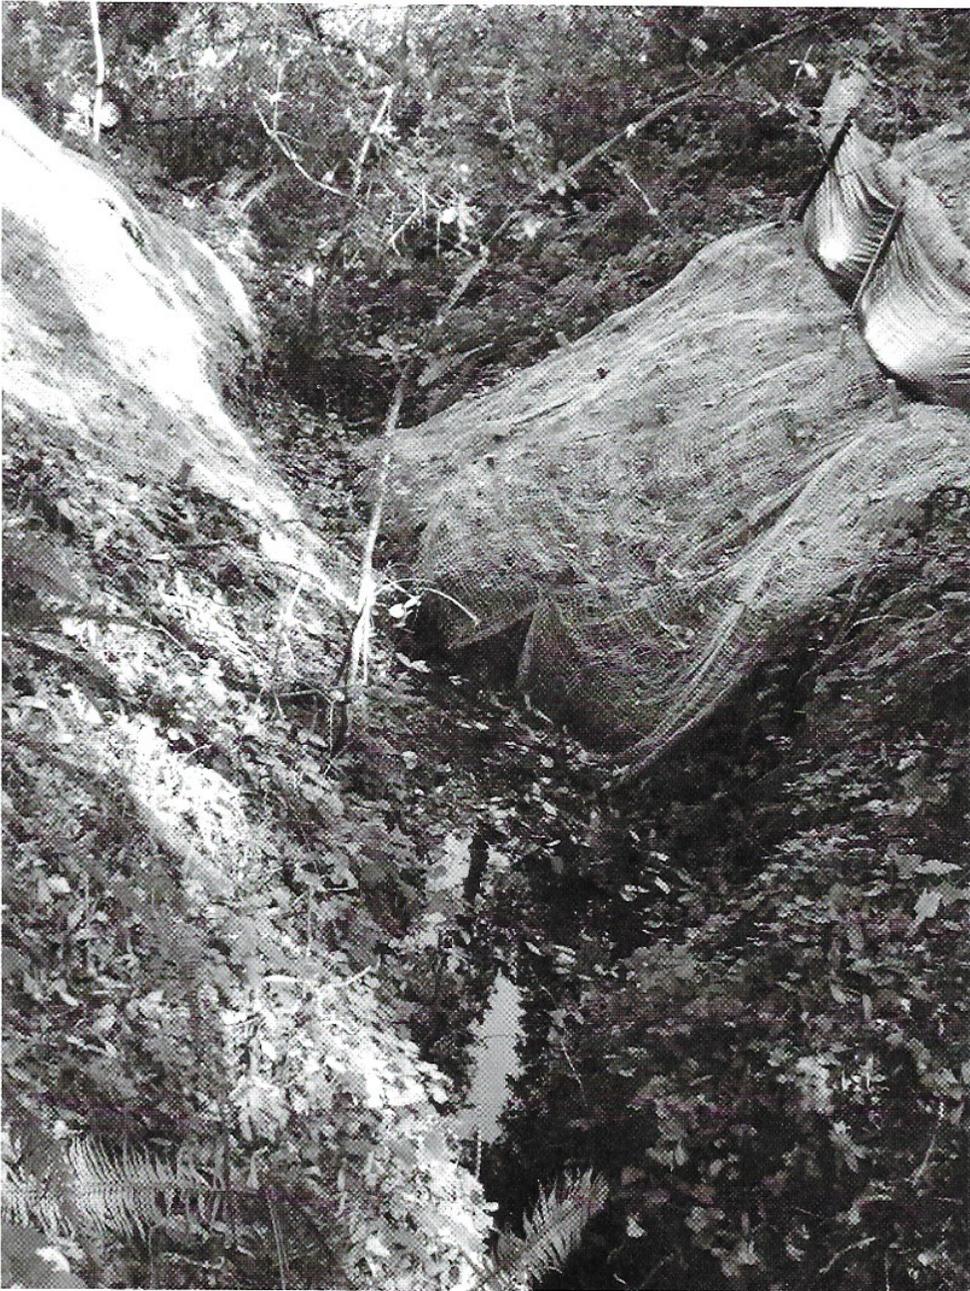
Photo 12. Drainage A in the location where the concrete bridge footings were poured.

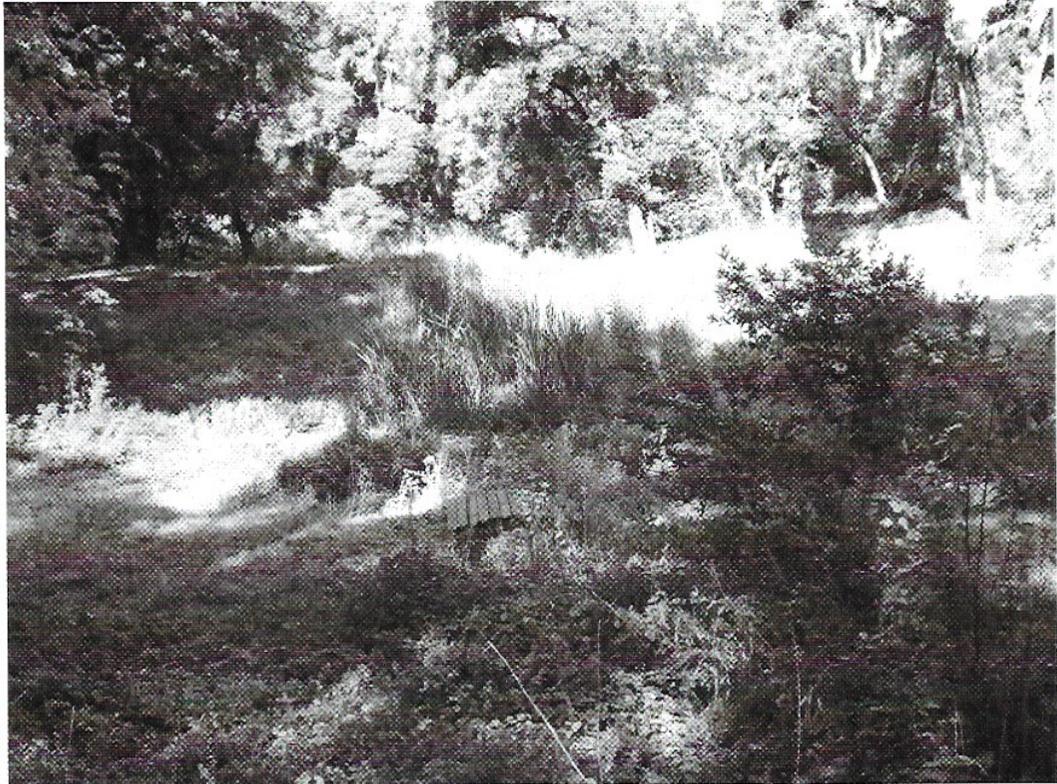
Photo 13. Second pond located on the subject property
