# memorandum

subject       Valleymar Bluffs Coastal Hazards Assessment: Estimate of Accelerated Bluff Erosion due to Sea Level Rise (ESA Ref. #D160715.00)

## 1. Introduction

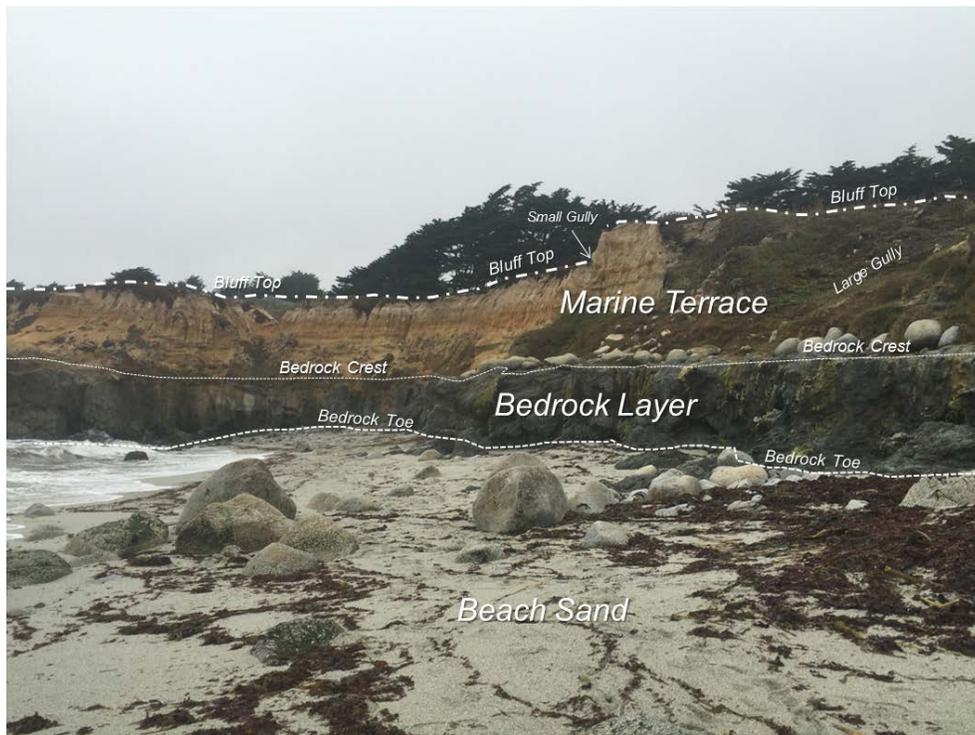
**Figure 2**  
Photograph of site on beach looking north, showing the stratified geology of the bluff

The geology of the site is stratified, with a layer of marine terrace deposits that overlays a bedrock layer known as the Montara Quartz Diorite (JCP 1990). Figure 2 shows a sandy beach with large granite cobbles and boulders is located in front of the exposed bedrock layer, which is approximately 5 to 15 feet above the top of the beach, and overlain by the marine terrace layer. Inspection of oblique aerial photography of the site archived by the California Coastal Records Project<sup>1</sup> indicates the sandy beach is seasonal. Photographs taken during winter and spring months show a rocky beach with waves breaking at the base of the bedrock bluff. Furthermore, the project area is mapped as an area of “low stability” and classified as unstable bluff material with erosion rate greater than one foot per year in a San Mateo County Geologic Hazards Map (San Mateo County 1975).

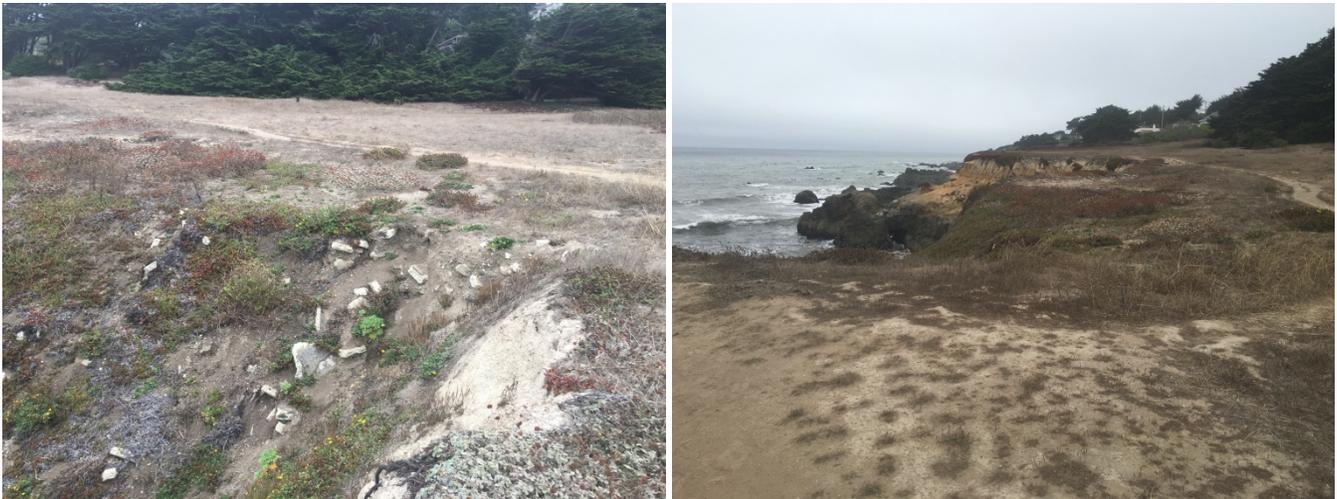
**Figure 3**  
Photos of the bluff top showing concrete debris and fill at the top of an active landslide (left) and the variability in the bluff edge caused by gullies (right)

The promontory opposite Lot D is located between two gullies: one relatively large gully filled with imported soil and debris, and a smaller gully that appears to have been formed by surface drainage and an exposed pipe. The locations of these gullies are shown in Figure 2. The large gully was described by JCP (1990) as an active landslide approximately 40 feet in diameter and affecting an area approximately 18 feet inland from the existing bluff top. JCP (1990) considered this an active landslide because signs of erosion along the bluff face were observed at the time of their study. A study by GeoForensics (2001) stated that several erosion gullies were present along the bluffs in a photograph from 1946, and extended inland from the face of the bluff as much as 90 feet. GeoForensics (1990) indicates that the gullies were filled by 1955, but have more recently been eroding. The left photo of Figure 3 shows imported concrete debris and fill located at the top of the gully that was described as an active landslide by JCP (1990). The photo on the right of Figure 3 shows the location of the “small” gully on the north of the promontory opposite Lot D, thought to be formed by surface drainage. An exposed metal pipe appears to have contributed to the erosion of the “small” gully (right panel, Figure 4). This implies that erosional factors other than average bluff retreat may contribute to future erosion hazards into Lot D.

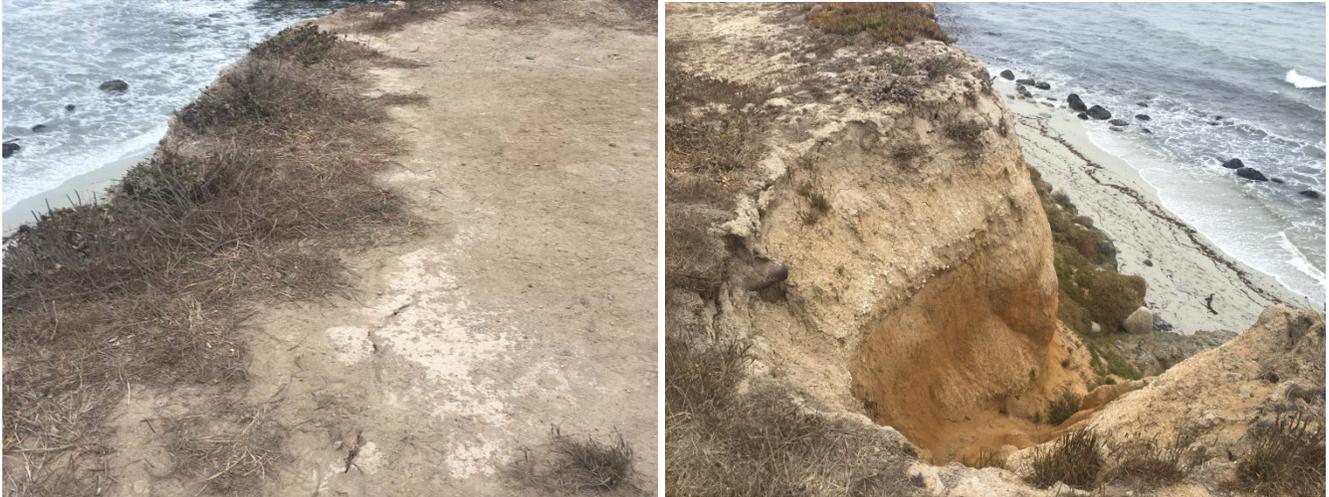
**Figure 4**

Several fissures were observed in the bluff top, which indicate that the bluff edge is in an unstable geometry and is prone to failure (left panel, Figure 4). The fissures are likely a result of the overly steep geometry of the marine terrace deposit layer, and indicative of the episodic nature of erosion. The photo on the right in Figure 4 shows the gully located immediately north of the promontory opposite Lot D.

Photos of bluff top showing a fissure or crack in the bluff (left) and a gully presumably caused by surface drainage (right)

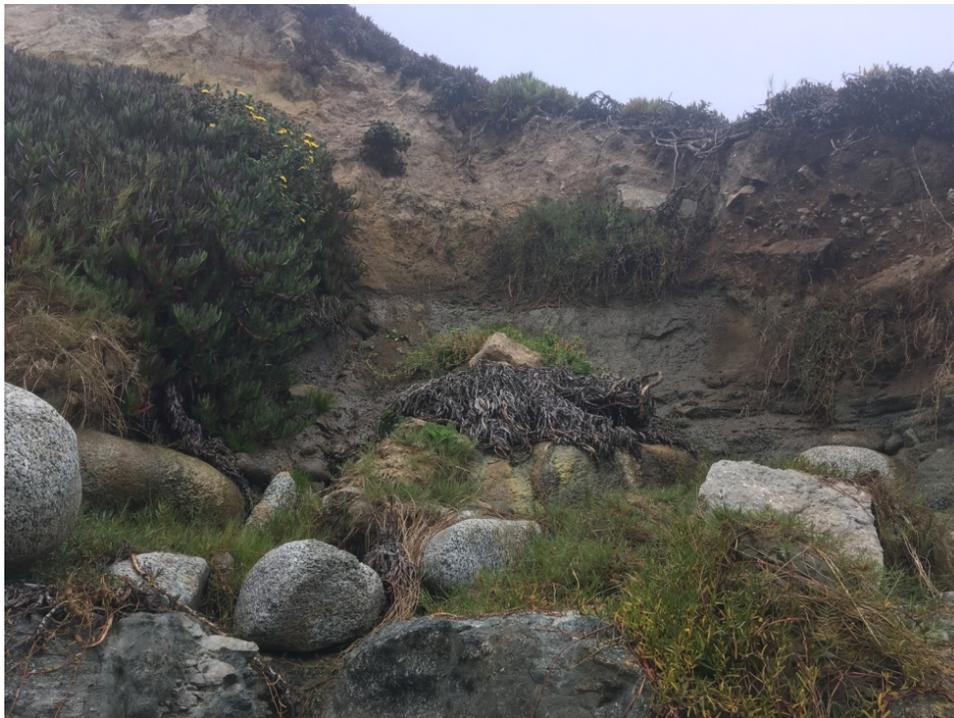
**Figure 5**

Areas of active erosion on the bluff, as well as groundwater seeps, were observed along the bluff. The photograph in Figure 5 shows a grayish layer of sediment with water seeping out of the face of the bluff. Areas of active erosion were observed adjacent to the wet bluff face, which may be contributing to the instability of the bluff. Areas along the bluff are also vegetated by a mix of native and non-native invasive species that may play a role in surface erosion.

Active erosion and seepage of groundwater on the bluff face

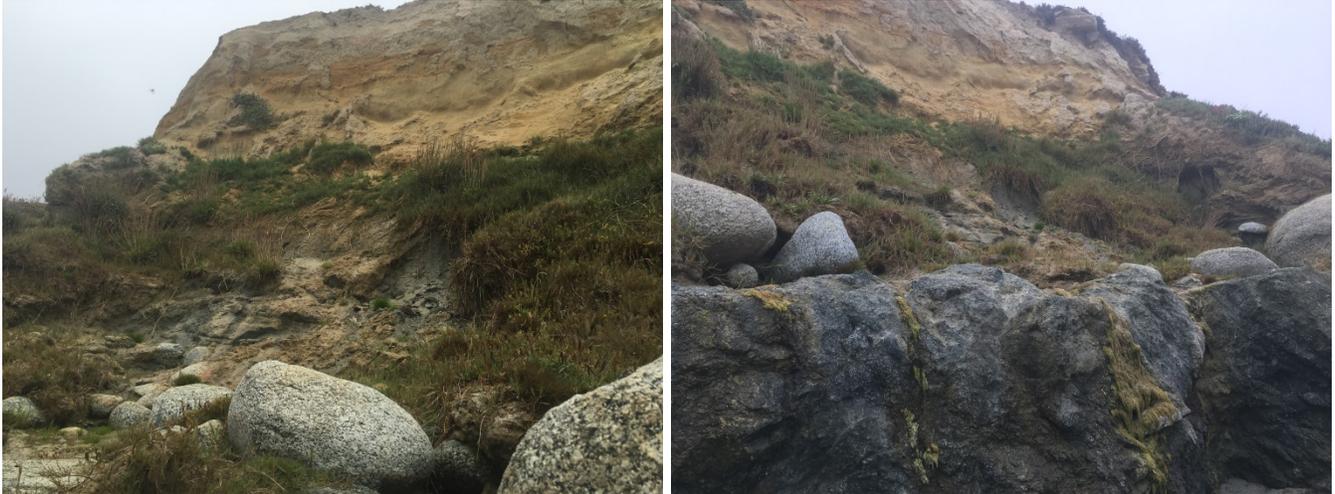
**Figure 6**

The photographs in Figure 6 show additional groundwater seeps and erosion that was observed below the promontory opposite Lot D. The water seeping out of the bluff runs down the slope and over the bedrock. Algae growths were observed at locations where the groundwater seeps run over the bedrock, possibly indicating that the seeps are active most of the year, and not only in the rainy season.

Groundwater seeps and erosion on the bluff face below the promontory opposite Lot D

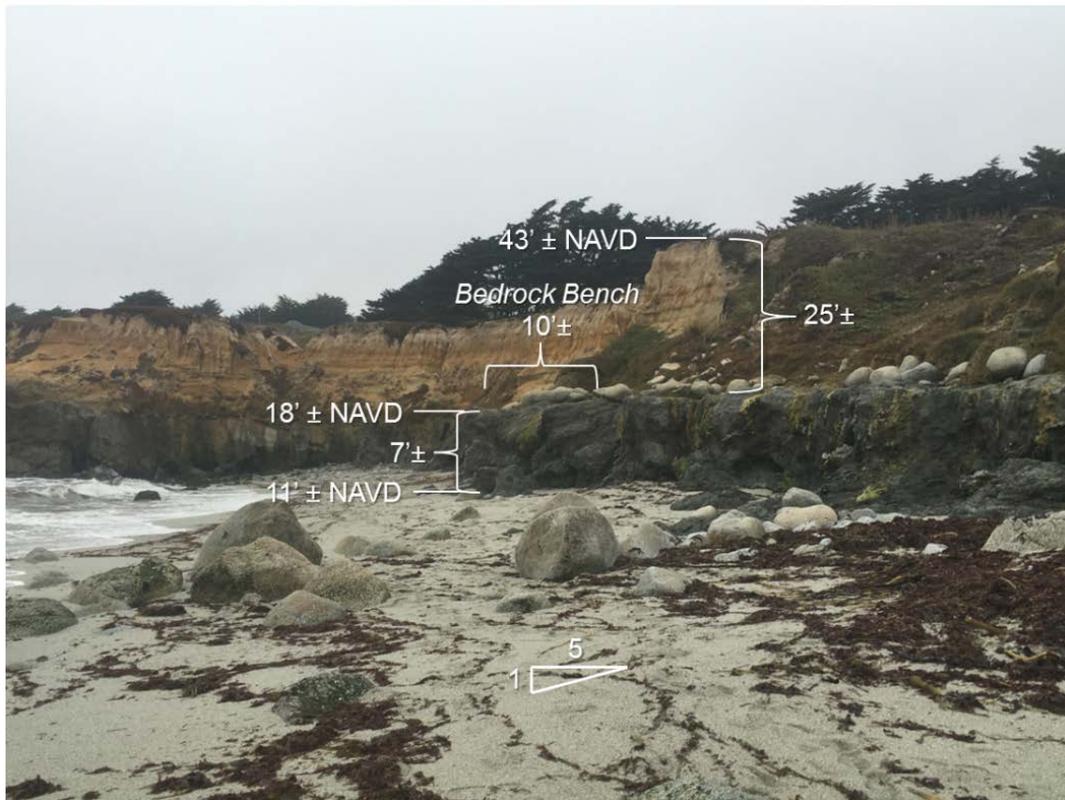
**Figure 7**  
Approximate geometry of beach and bluff

Figure 7 summarizes the key information from the topographic survey, including dimensions, elevations, and slopes of features. The dashed blue line is located approximately where we surveyed a profile across the bluff and beach. The elevation of the edge of the bluff was measured to be approximately 43 feet NAVD, with some variability along the shore. The marine terrace deposits in this location stand almost vertical and are approximately 25 feet tall. The elevation of the bedrock layer was approximately 18 feet NAVD, although it also varied along the shore, and was approximately 7 feet above the top of the beach. A small “bench” was formed on the bedrock top as it extends seaward from the base of the bluff. The bedrock bench from the bluff toe varied between about 5 feet and 15 feet along the shore, likely a function of the relative exposure to waves breaking near the bedrock and bluff. The bench was not observed toward the north end of the beach, likely because of the presence of a large promontory that extends into the surf zone and protects the northern pocket of the beach from the larger breaking waves. Boulders and large cobbles were observed in the surf zone at approximately the low tide platform, and along the beach. Several boulders were sitting on top of the bench formed by the bedrock, which were likely moved by waves during extreme coastal conditions.

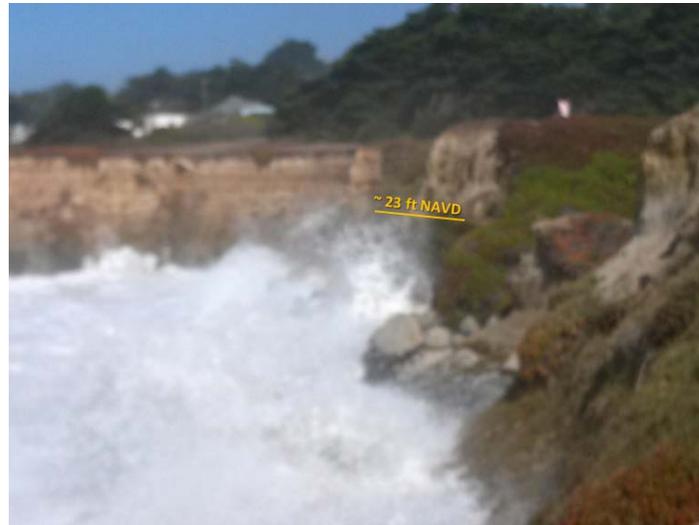
**Figure 12**

The wave runup model was calibrated by comparing model output to observations made at the site on October 17, 2016. We used a photograph of the site and observations taken on October 17, 2016 during high tide to estimate a TWL of approximately 23 feet NAVD. Based on the topographic survey, the top of the vegetation shown in the photograph is approximately 23 feet NAVD, which appears to agree well with the spray of the wave. Also note that the reference water level is high compared to the beach, likely due to wave setup caused by the long period swell hitting the coast on that particular day. We ran the modified TAW model using the measured tides from NOAA and nearshore waves from CDIP for the same time period, and calibrated the runup component by adjusting a roughness coefficient so that the model output was similar to the observed data.

Estimate of total water level based on observations made on October 17, 2016
