Re: Updated Biological Resources Addendum Letter for APN 037-015-090, Montara, California

**Re: Biological Resources Addendum Letter for APN 037-015-090, Montara, California –
Current Conditions as of October 16, 2018.**

**Re: Biological Resources Addendum Letter for APN 037-015-090, Montara, California –
Current Conditions as of May 14, 2020**

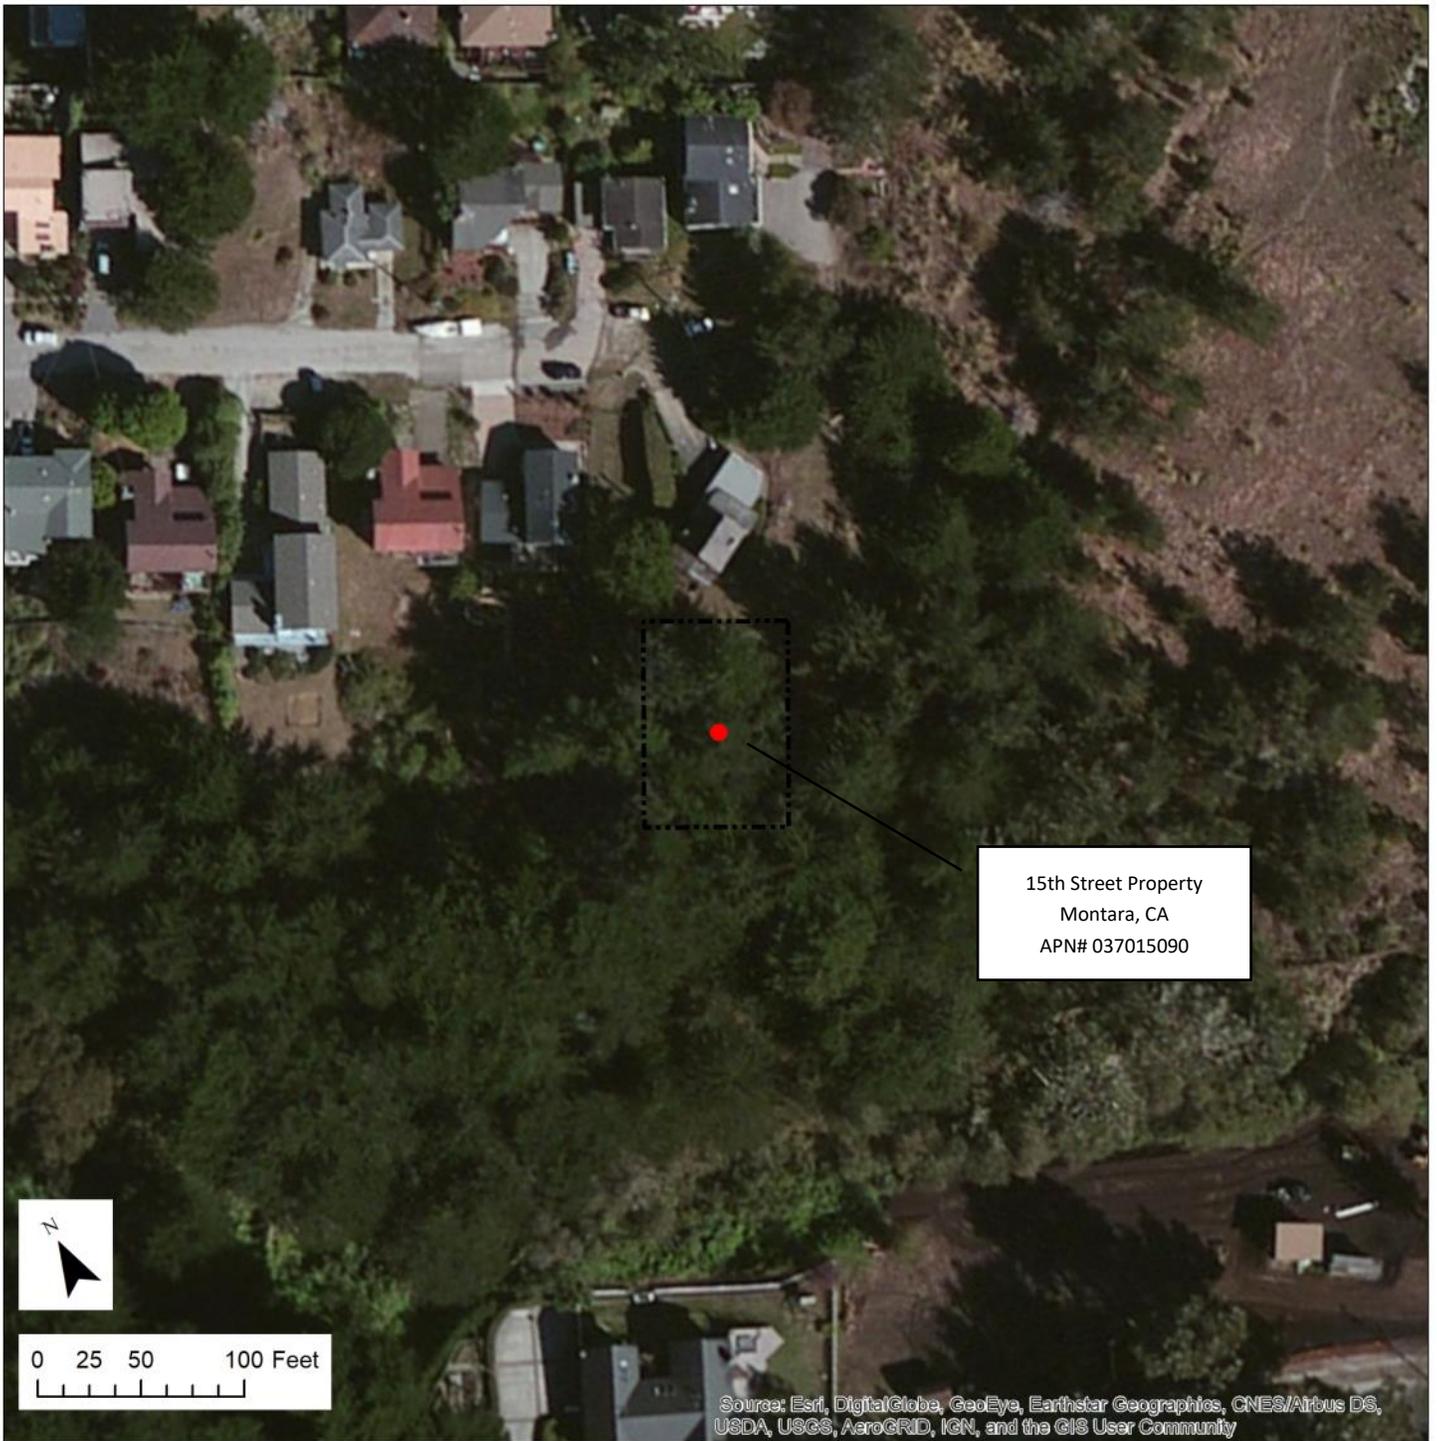
Figure 1: Project Site Location
15th Street Property, Montara, CA

The proposed project is for the development of a single-family residence and driveway on an undeveloped 0.31-acre parcel (APN 037-015-090) located at the terminus of 14th Street in Montara, San Mateo County, California (Attachment A: Figures 1 and 2). Vegetation communities observed on site are consistent with those described in the 2015 WRA report.

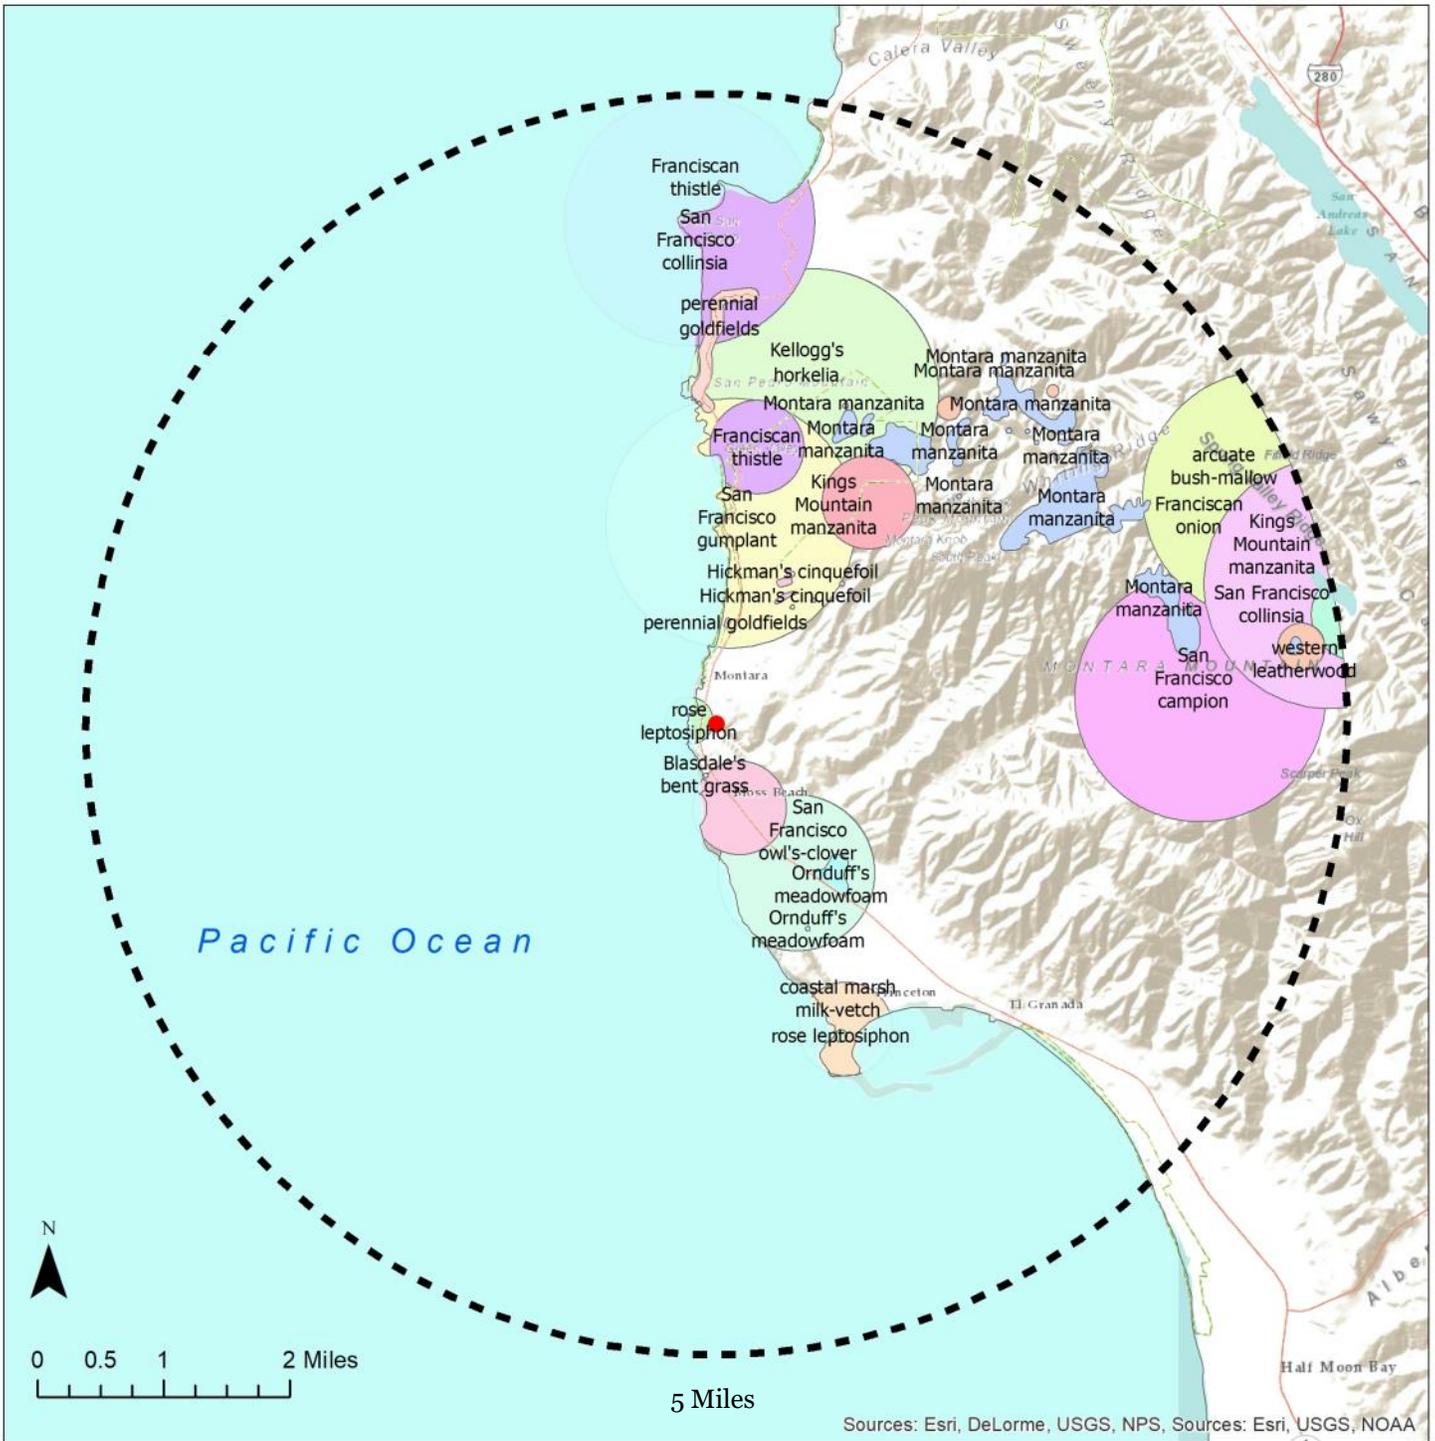
Figure 3: Special Status Plant Species within 5 Miles of the Project Site
 15th Street Property, Montara, CA

Twenty-one special status plants and ten special status wildlife species have been documented within five miles of the Project Site (Attachment A, Figures 3 and 4). A discussion of the potential for these species to occur is described below.

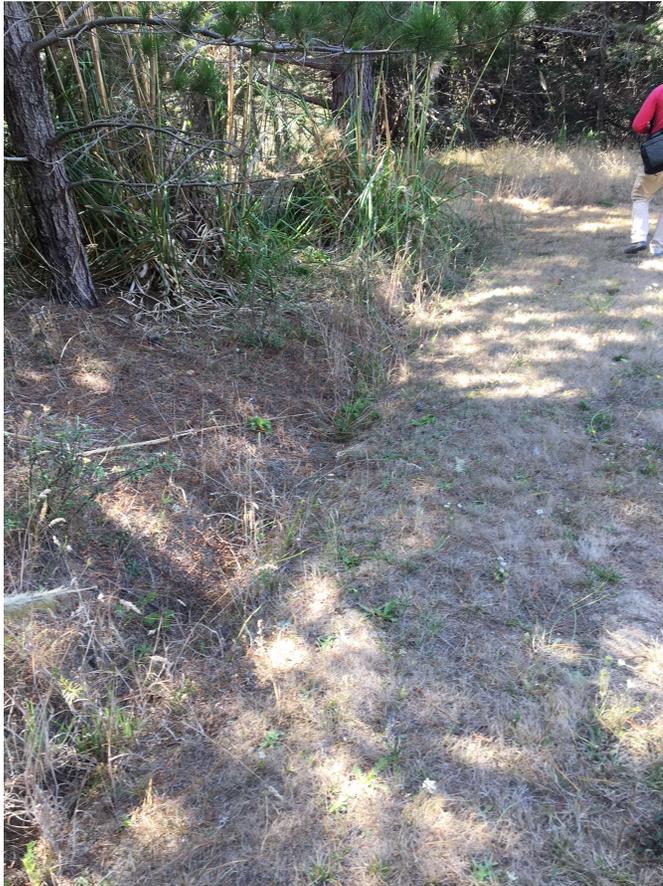
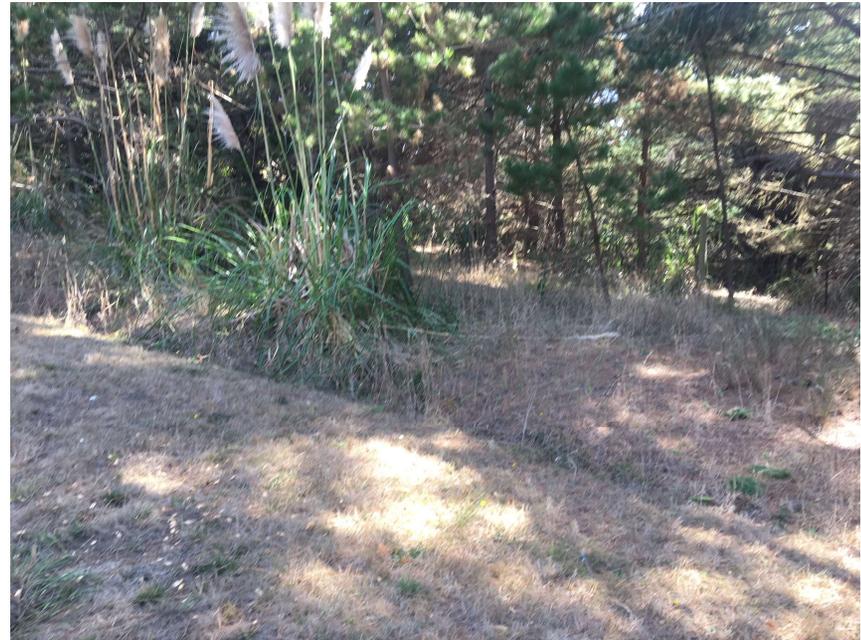
View of erosional feature on adjacent parcel between unnamed tributary and subject property.

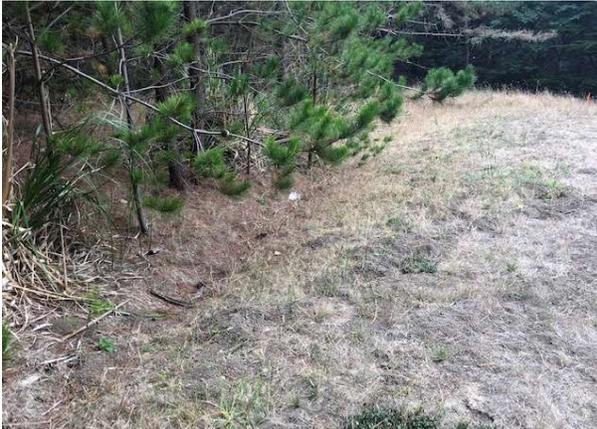
A convergence of topography is seen on the proposed driveway; however, no hydrologic, vegetative, or soil indicators as described in the 2017 report are currently present.

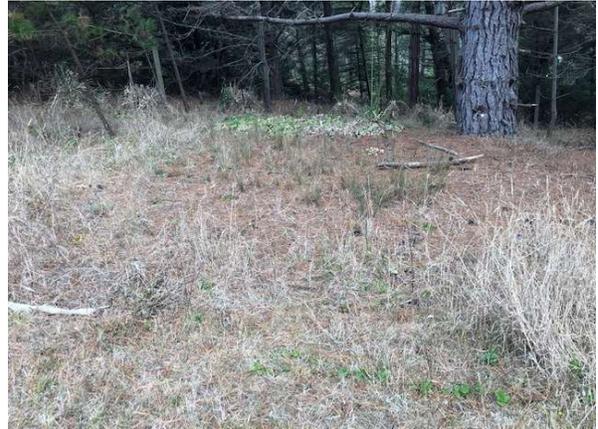
Bulrush (*Juncus spp.*) was observed within the dripline of pine trees on the site where fog drip is likely to occur.
